Consultancy Services for Development of Disaster Risk and  
Early Warning Systems in Ghana

## **Risk Profiles of Hotspots in the Pilot Districts**

Technical Report

UNDP Ghana

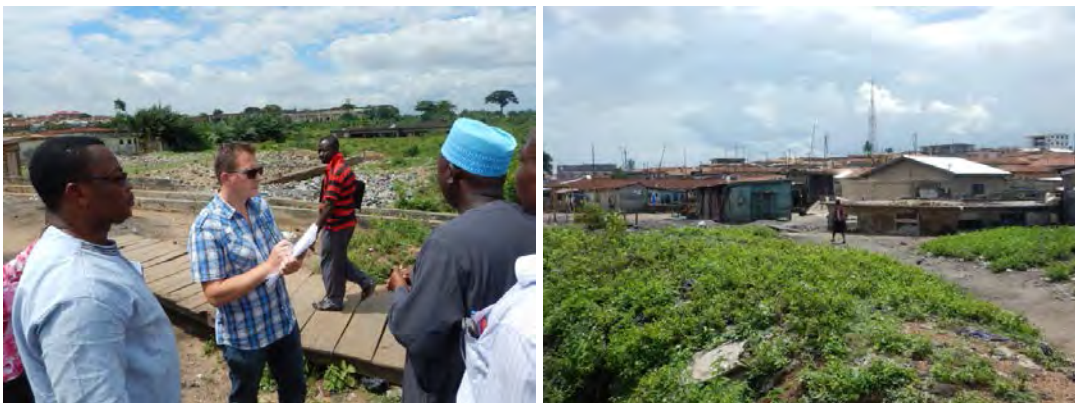
The community is located in an area along the Sisan Akyi River. The area suffers from regular flooding. The local people indicated that flooding occurs 3 to 4 times a year when the river breaks its banks and inundates the community. Apparently the river is blocked by debris and silt more downstream. The Sisan River drains into the Ofin River just south of the Eastern By-Pass. Currently the situation is worse than it was 20 years ago. When the floods happen the people are warned by community officers and advised to leave the houses as the flood waters can rise up to 1 meter above floor level.

Figure 3 Interview with local people along the Sisan River (left). Houses along Sisan River vulnerable to frequent flooding (right)

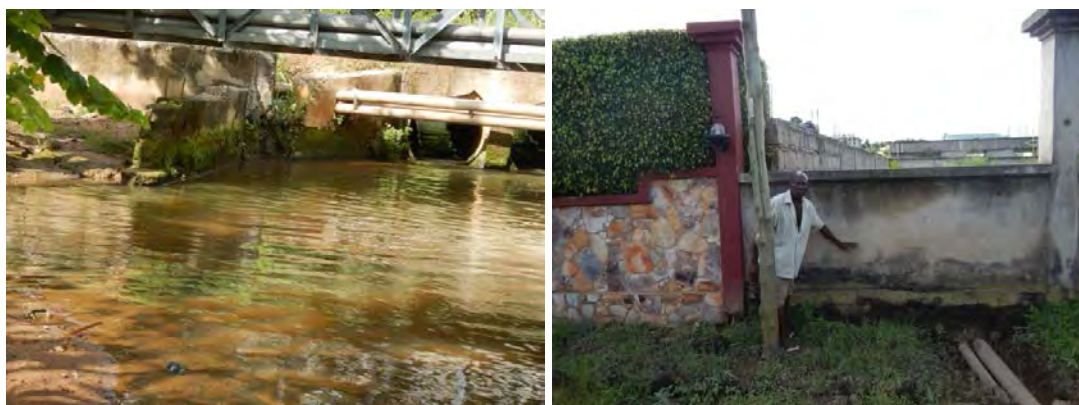
The community is located in an area along the River Subin. The area suffers from regular flooding. A local man who lives along the river indicated that flooding occurs 3 to 4 times per year when the river breaks its banks and inundates the area up and downstream of the main road. The river is blocked by silt and vegetation.

Figure 4 . River Subin (left) and man indicating height of flooding at Anwomeso (right)

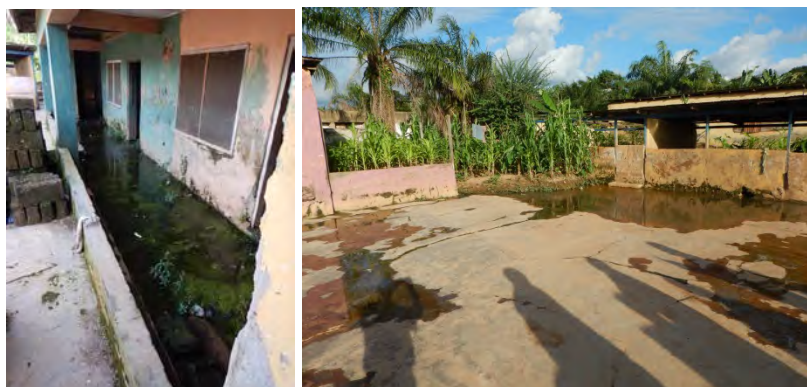
The whole stretch of houses along the river Abonsna River is located in an area that is extremely wet with very high groundwater levels. The area suffers from regular flooding as it is situated in a low lying area. Retaining walls have been constructed to keep the water out of the houses. A local resident who lives in a block where two little boys were drowned due to flooding caused by a wall break last year indicated that too much water comes down to the place.

Figure 5. Asnoyeboa: abandoned school building (left) and ground water seeping through concrete court yard (right)

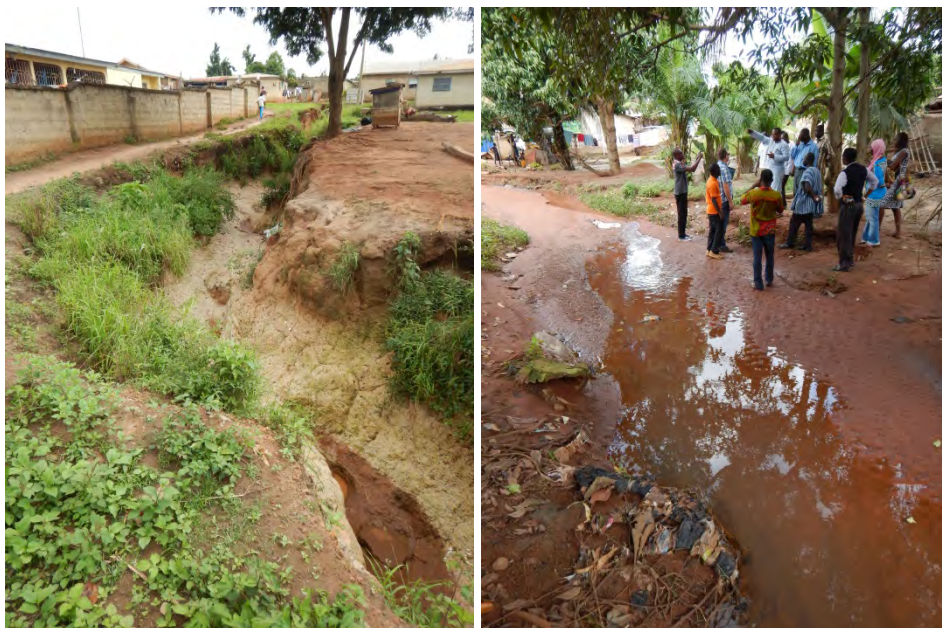
The community is located in an area where a heavily eroded drainage channel flows from upstream to downstream. The area suffers from regular flooding. The drain seems not to have sufficient discharge capacity and erodes the area. Halfway down the slope, a house blocks the streamflow and a bypass is created by the owner. Some local people indicated that the flooding occurs 3 to 4 times per year when the drain inundates the community. There are some feasibility studies available at the Techiman Municipal Assembly (TMA) which might be useful.

Figure 7. New Onyinase: images of the drainage channel

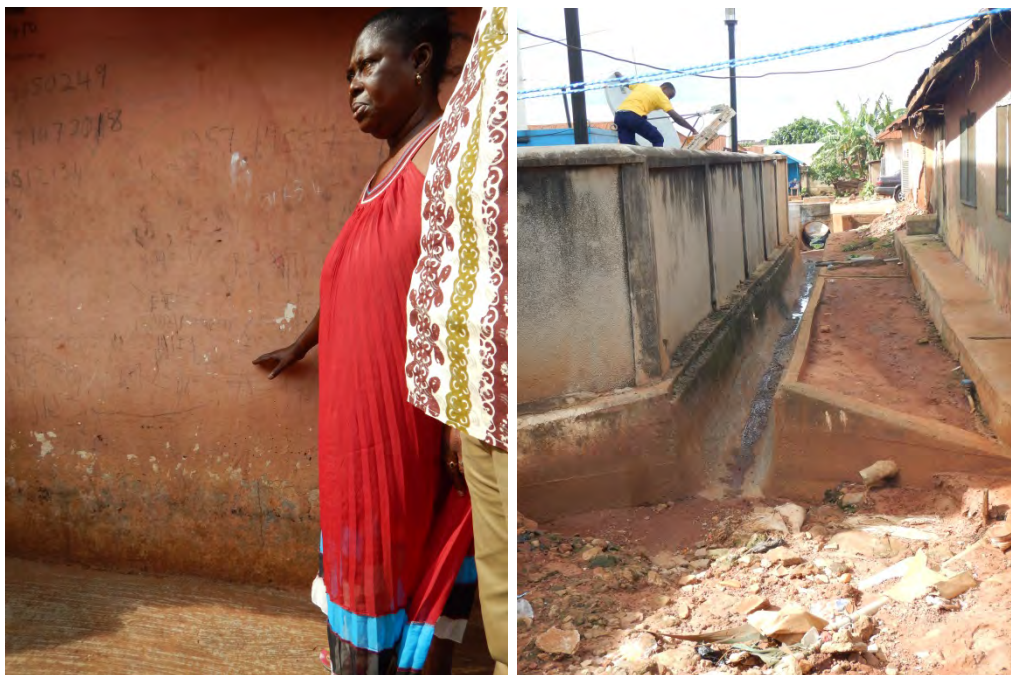
In the middle of the town centre an area located behind Techiman-Nkonsia Road suffers from regular flooding. It is assumed that the water comes from the street but in fact the upstream area has no proper drainage system in place. The water flows freely downstream and eroded a gully to a depth of 0.8-1.0m before connecting to a lined channel (see picture below) downstream.

Figure 8. Ahenbronose: indication of flooding level (left) and lined outflow channel (right)

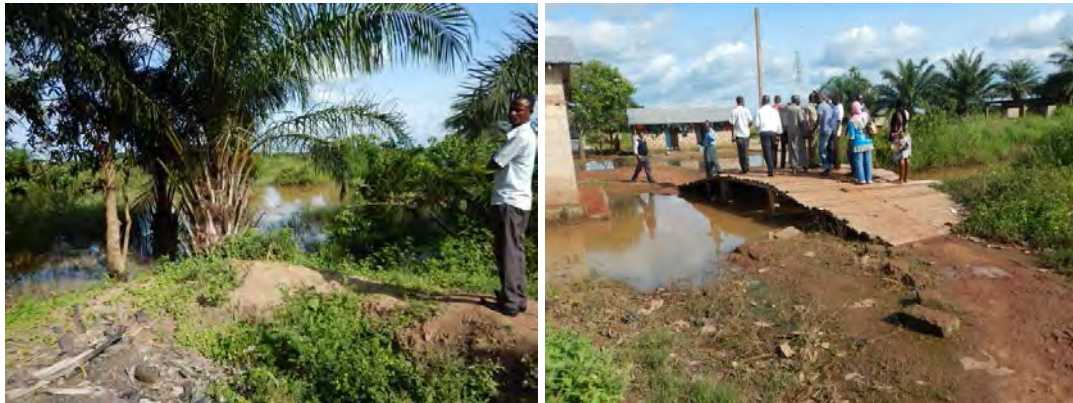
This area suffers from regular flooding caused by the fact that it is a ponding area, all the water flows to this area. No drains are available and the houses get flooded

regularly. The area is wet and a little wooden bridge is constructed to connect the houses.

Figure 9. Twinia Nkwanta: images of the area

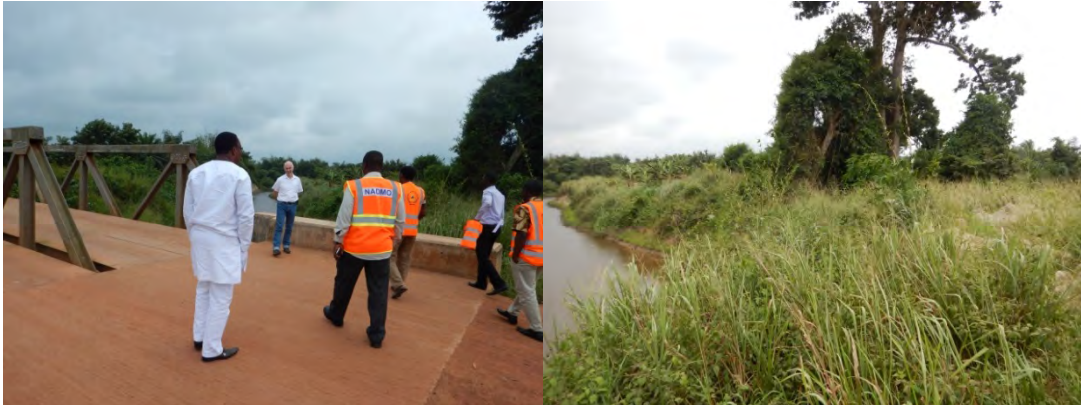
The hydraulic gradient of the Kakum river in this part is low, the river is meandering strongly in this area. This means the sedimentation in the river is high, causing a reduction in the storage capacity of the river bed. In 2013 NADMO cut one river loop just upstream of a bridge (Figure 14) to alleviate the problems a bit. The river bed was dredged and the sediment of the river was used to raise the river bank. The newly formed river banks were planted. The roots of the plants hold the soil very well. The community would like to have more NADMO input to straighten the river's course further and to keep the river bed open. Straightening the river as suggested by the community's spokesperson would lower water levels upstream of the intervention while it could raise water levels downstream, where high tides pose a problem to evacuate the flood waters.

Figure 14. Upstream of bridge (stop 1) – the place where the river was dredged. Sediment was used to strengthen the river bank.

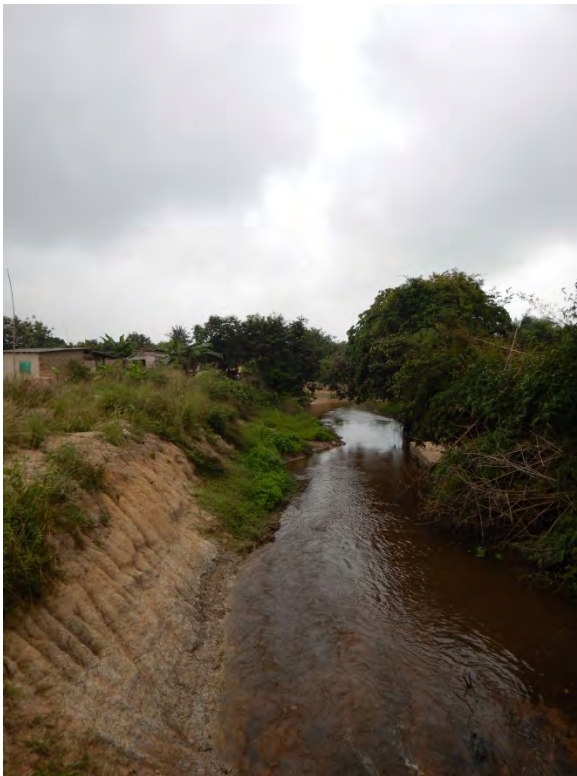
Figure 15. Downstream of bridge (stop 1) – on the left the river bank shows signs of erosion and sedimentation in the river bed. The houses build on the river bed are vulnerable to flooding.

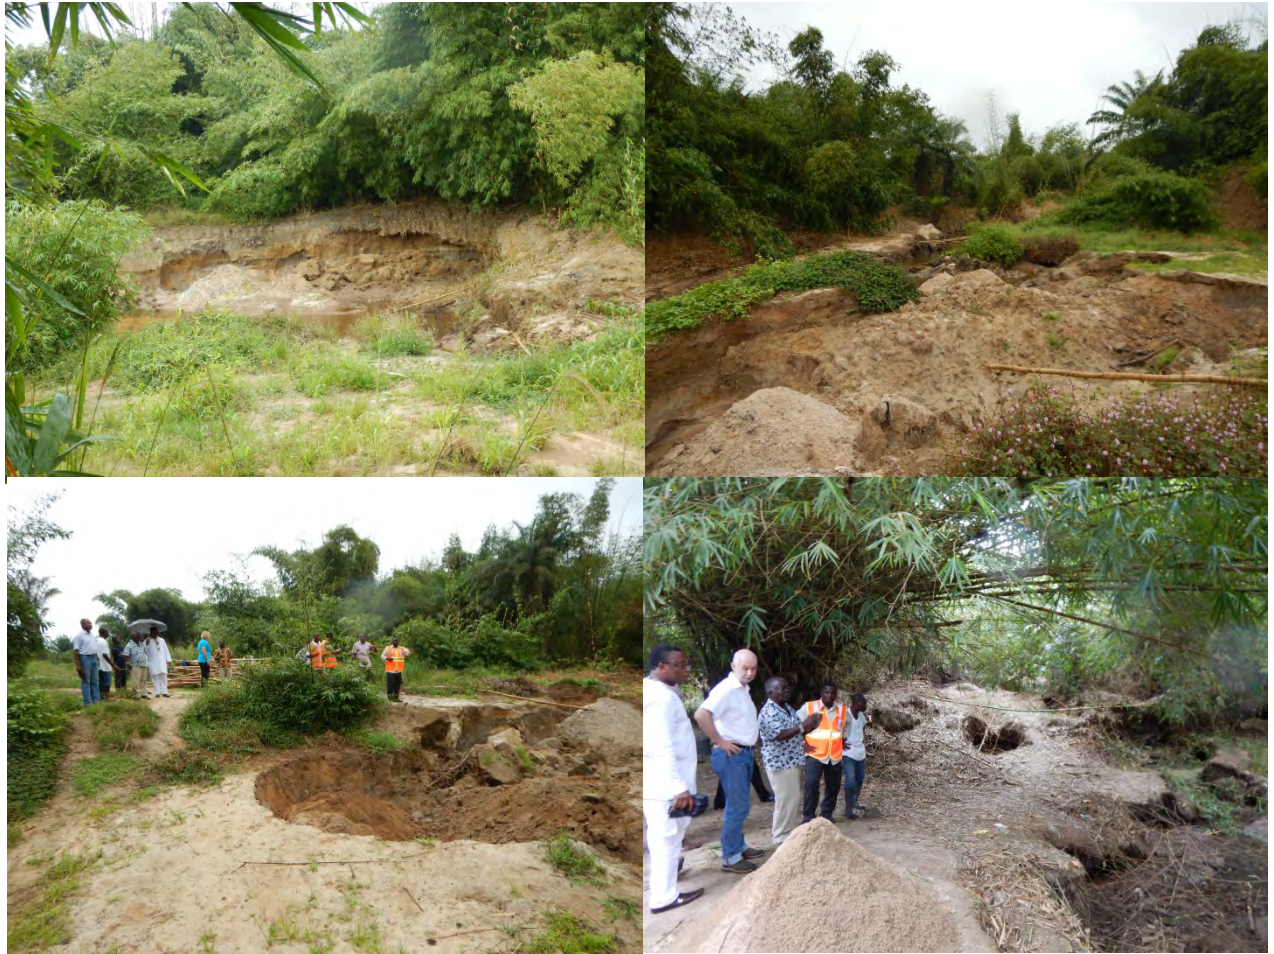
The second and third spot visited showed clear evidence of sand mining in the river bed. This activity risks to change the river's course in some spots and poses a significant cave-in risk to the sand miners who often work under overlying topsoil layers. The sand mining does seem to have an effect on the river's course but the effect on the flooding seems to be doubtful. Increased sedimentation however can cause a reduction in discharge capacity.

**Figure 16. Evidence of illegal sand mining at stops 2 and 3.**

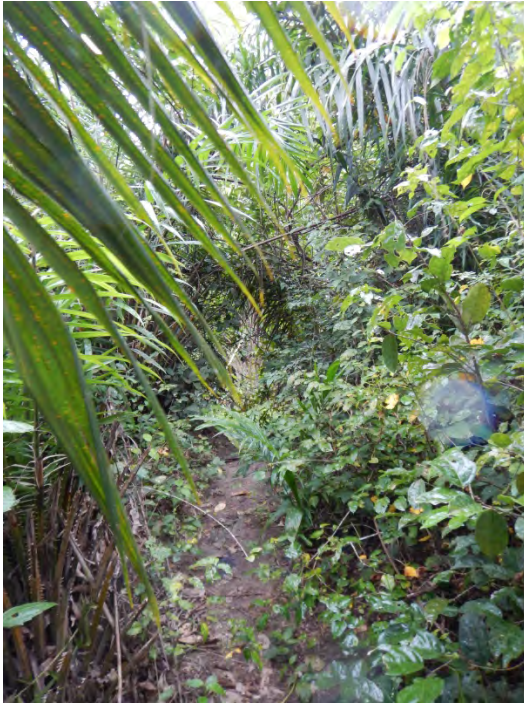
Another problem that was identified in the field is the fact that local residents create paths through the river banks. These are weak spots where water flows from the river into the community (Figure 17).

Figure 17. Local path from community to river bed, around stop 2 that leads to a local lowering of the river bank. From here the river water enters the community.

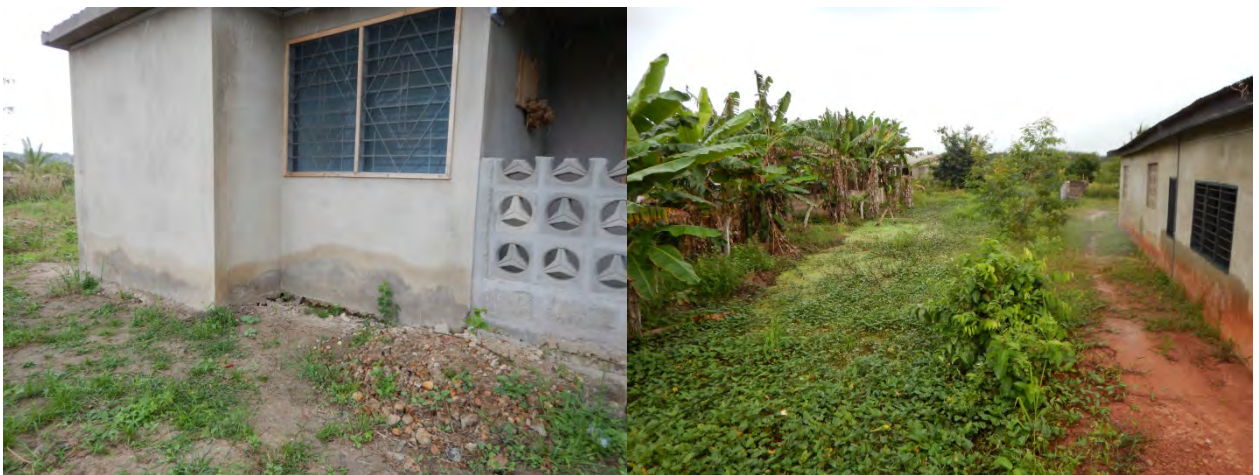
The fourth site we visited showed how the natural drainage system of this wetland was blocked by construction. Unsufficient drainage capacity leads to a prolonged presence of flood waters. This causes problems to the foundation of houses (Figure 18) but also poses a health risk (cholera, mosquitoes etc.) and according to our spokesman even crocodiles. A restoration of the local drainage capacity and construction of new drainage systems seems necessary to alleviate the problems in the area. Our local expert from the University of Cape Coast (Dr Nyarko) has already done some model studies to determine what type of new drainage system would be able to take on this task.

Figure 18. Houses within Kwapro community of which the foundation is affected by regular flooding.

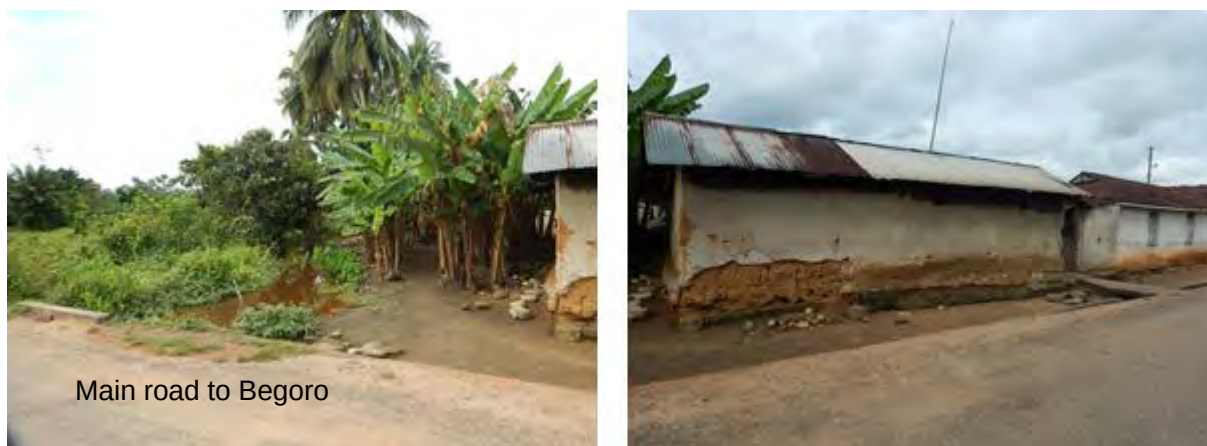
The town of Besoso is regularly flooded by a small stream that flows through the town. Figure 20 shows the stream on the left and the flood marks on the houses on the right. Flooding can occur all year round and is typically caused by several days of rain accumulating in the area. Once the upstream rural areas are saturated with water, the flood wave comes fast. Casualties have not been recorded, but a large part of the city is flooded with at least half a meter of water. Additionally the entrance road to the town, which is also the main road to the district capital, is often flooded as well. Figure 20 shows how close the normal water level is to the street level.

Figure 20: Besoso: stream (left) and flood marks (right)

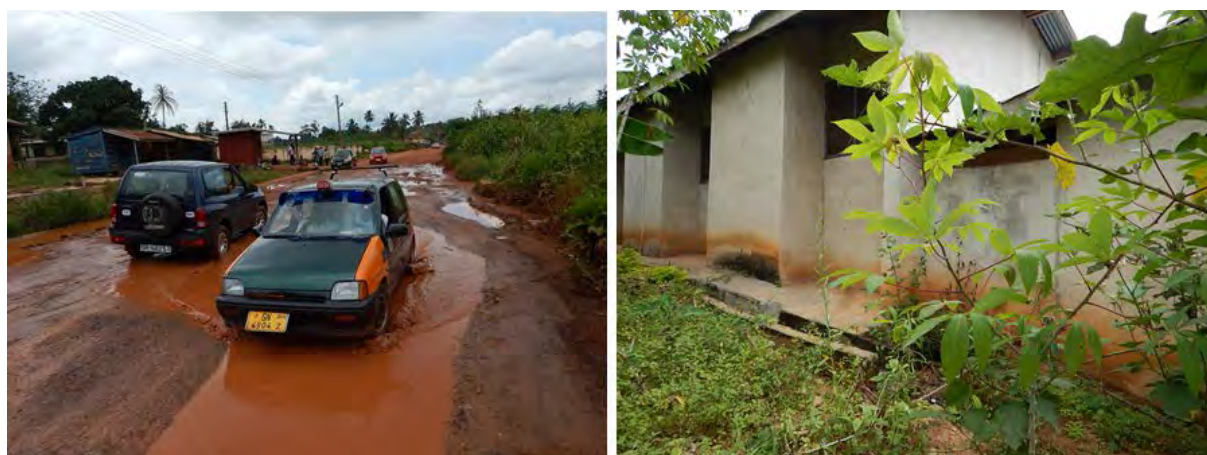
Begoro is the district capital. The hotspot area is located in the northern part of the town in the Dansor Begoro township. This area is flooded several times per year after consecutive days of rain. Figure 21 shows flood marks from a few days ago on the road and nearby buildings.

Figure 21: Begoro: flood marks

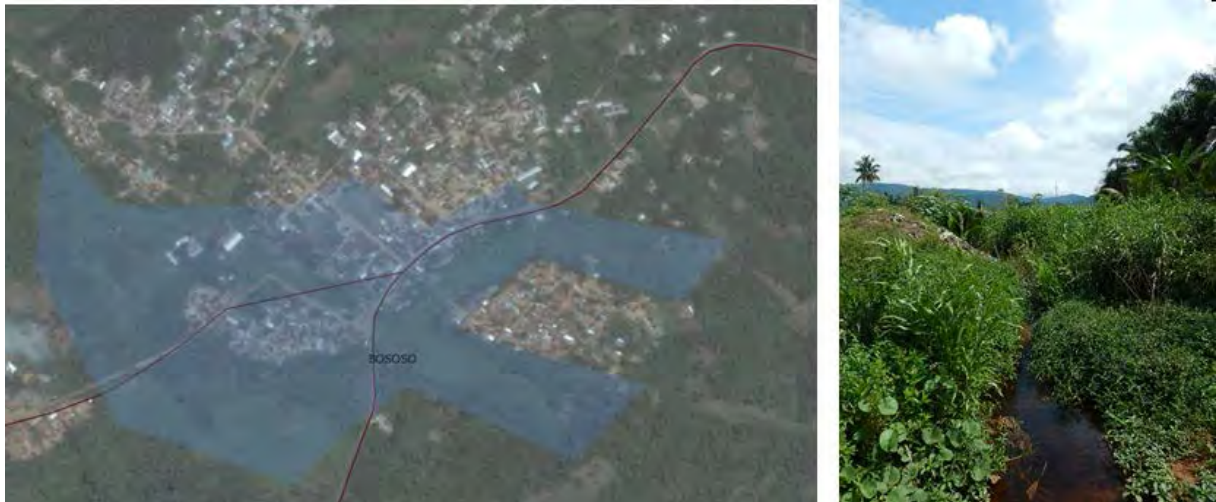
From interviews we concluded the area shown in Figure 24 has recently been flooded. The flood wave travels in a south-westerly direction. The town is built in a low lying area where several streams come together. Additionally, the right hand side of Figure 24 shows a dump site, that is blocking the river flow. The figure also shows the areas dense vegetation that blocks the drainage of the area.

Figure 24: historical inundated area and cause of the flood hazard in Besoso

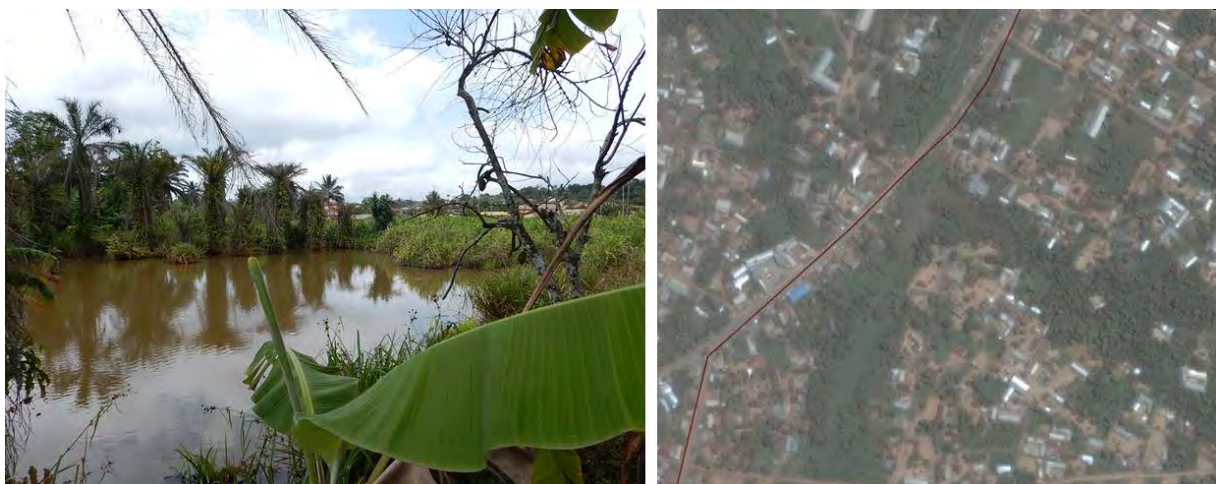
Dansur Begoro area does not show on the flood hazard map. This is because the floods in the hotspot area are mainly due to a local construction mistake: the low lying area collects a total of 9 streams and drains: three from the west and 6 from the east. The west drains are not connected properly and are blocked by the street. Culverts under the street are blocked and some planned where never constructed. On the east side 6 streams accumulate in a low lying area of which the downstream part is fully overgrown. The vegetation and debris functions as a weir which overtops once the area is full. Once full and saturated, every rain event immediately causes a flood from the east side.

Figure 25: Water accumulation east of the hotspot of Begoro

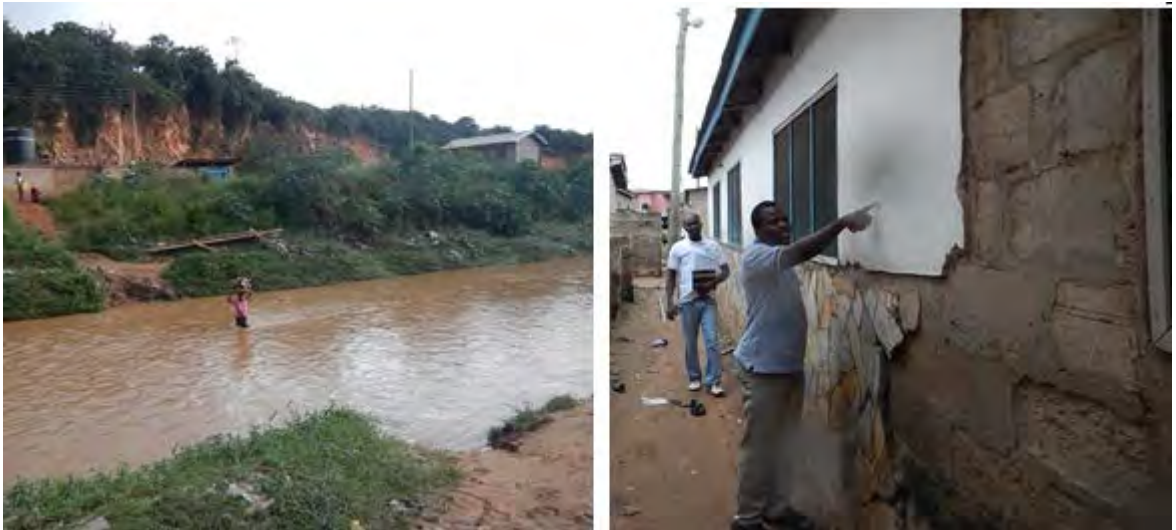
small flash flood washed away the mobile bridge that normally connects this side of Alogboshie with the local school. The bridge is chained and can therefore be reinstalled easily. However, due to this flexible construction, it cannot always be used and as the picture shows, people are sometimes forced to walk through the river. The local assembly representative informed us that this causes fatalities each year. The right hand side photograph in Figure 29 shows the historical water level in the Alogboshie area during large floods.

Figure 29: Alogboshie : washed out bridge (left), historical water level (right).

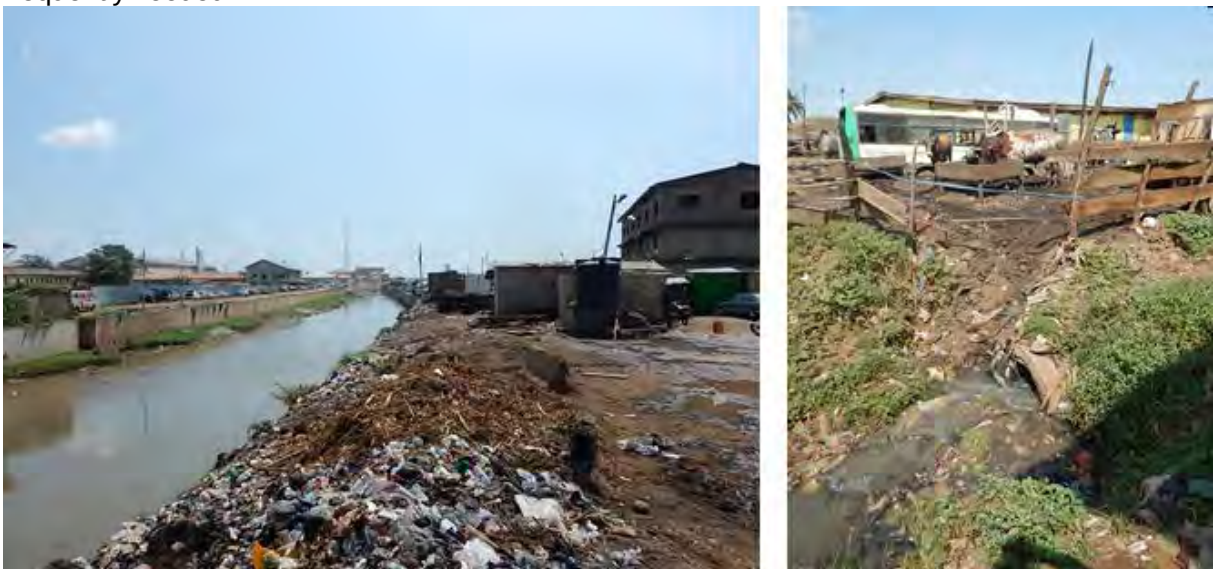
Figure 30 shows a picture of the Odaw drain in the Avenor area, where the right side is frequently flooded.

Figure 30: Odaw drain and local drain flowing into Odaw drain

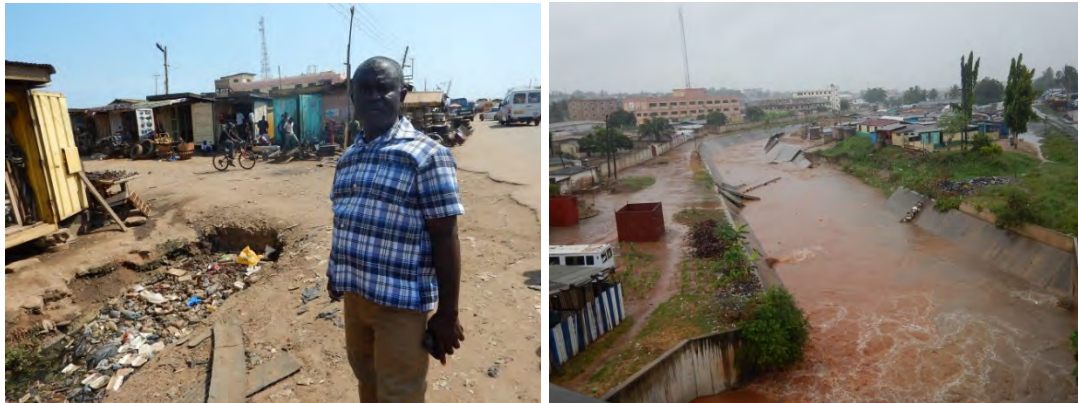
The discharge capacity of the drain has decreased not only by narrowing the channel, but also by siltation and solid waste deposits and accumulation. The drains and streams connecting to the Odaw drain suffer from similar problems. Figure 34 shows an example of blocked local drains in the Odaw catchment due to waste deposits. The right hand side picture illustrates how Odaw drain is canalized and parts of the bank protection are washed away, causing flow blockage and trapping of additional debris. The picture also shows how fast the river reacts: The high flows captured in the picture are caused by a rainstorm that started an hour before.

**Figure 34: Examples of waste deposits in the Odaw catchment (left Avenor) and bad maintenance of the Odaw drain (right south Alogboshie)**

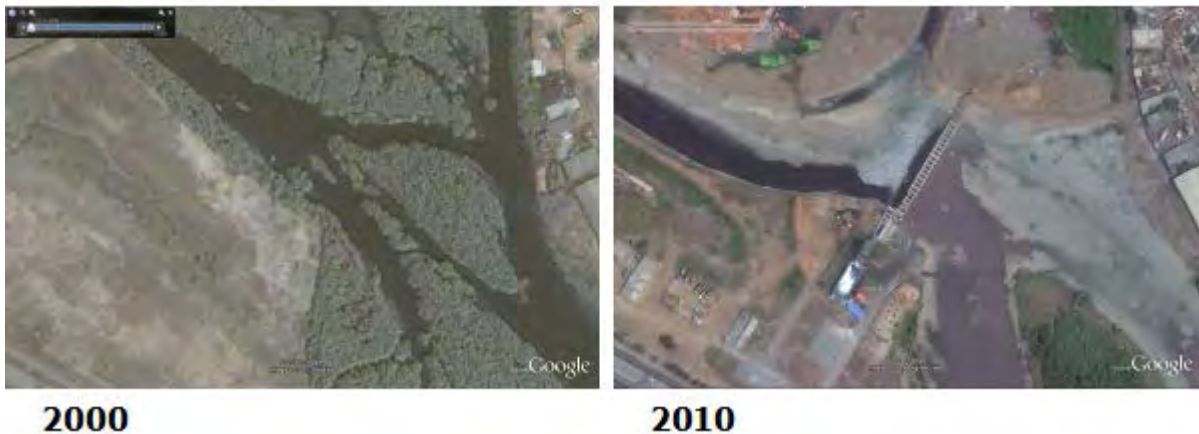
Between 2004 and 2008 just upstream of Korle Lagoon a so-called interceptor weir was constructed, intended to intercept solid waste and wastewater before entering the Korle Lagoon (Figure 35). The weir should be opened during high flows from upstream, but solid waste is easily trapped behind the weir, blocking the flow to the sea. Additionally a flash flood can coincide with high sea water levels, as was the case during the flood of 26 October 2011.

**Figure 35. Korle Lagoon – in 2008 just upstream of Korle Lagoon a so-called interceptor weir was constructed**

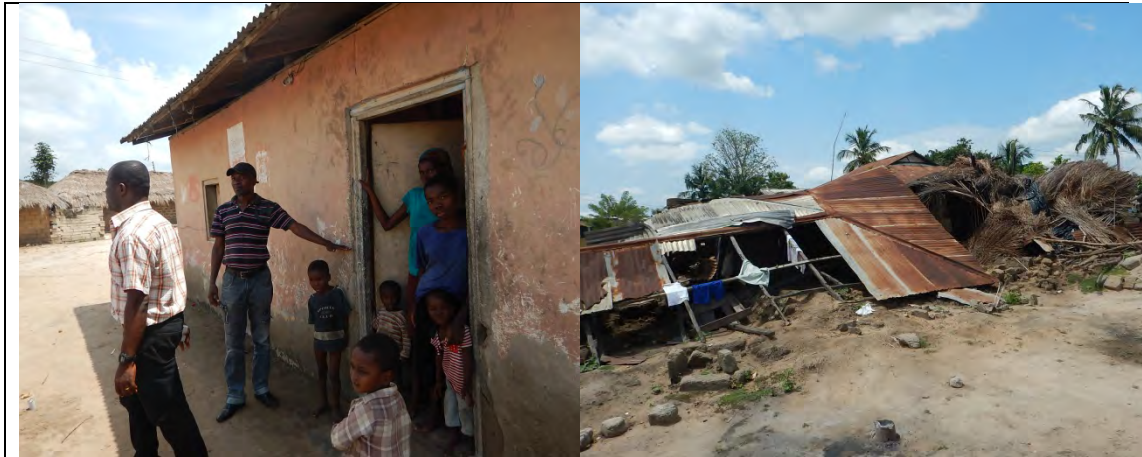
Figure 55: Resident indicates flood level (left), visible damage in the village due to flooding (right)

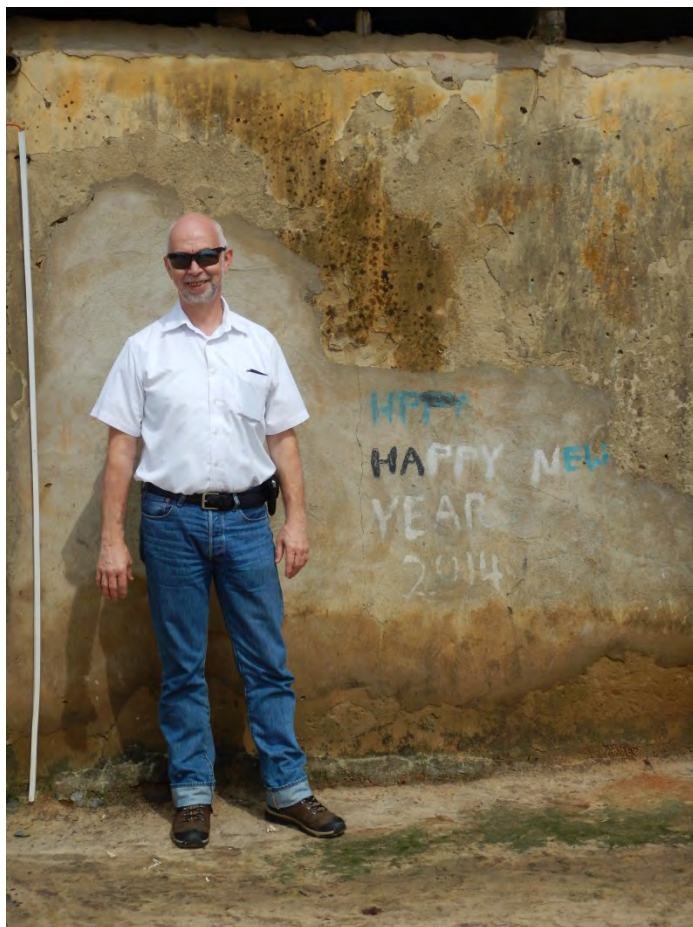
Figure 63. Flood level indication – recent flood level was at the height of the writing ‘Happy’
