**STRUCTURAL SYSTEMS  
RESEARCH PROJECT**

Report No.  
SSRP-2001/02

**RECONNAISSANCE REPORT OF THE  
FEBRUARY 28, 2001 NISQUALLY  
(SEATTLE-OLYMPIA) EARTHQUAKE**

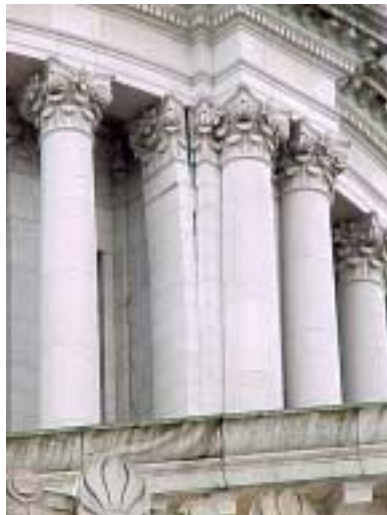
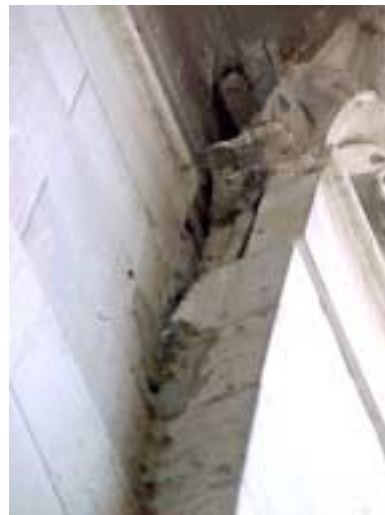
Damage to this structure is clearly evident from the severe cracking of the nonstructural sandstone pilaster from one of the exterior masonry buttresses supporting the dome, as shown in Fig. 3.1.2. This dislodged pilaster seemed wedged against the top portion of the structure, which prevented it from falling. Also at the time of writing, cracking had just been discovered in some of the ribs of the dome.

**Figure 3.1.2** Severe Cracking of a Nonstructural Sandstone Pilaster at the Dome of the Legislative Building in Olympia.

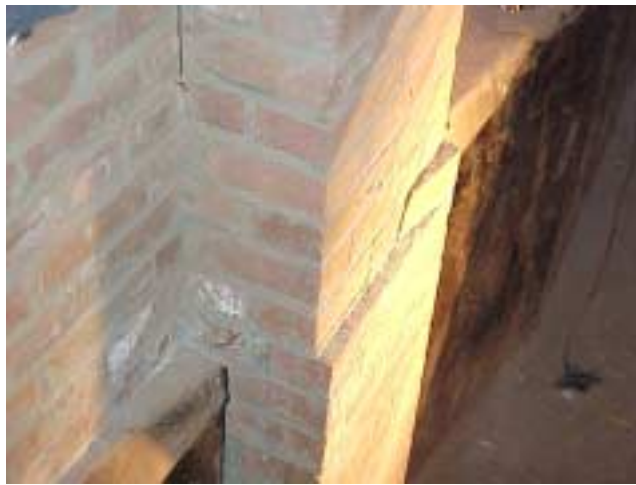
Significant differential movement occurred between the drum and the lower masonry portion of the building, as shown in Fig. 3.1.3. Preliminary engineering reports indicated that the drum wall would have deformed as an oval and also rocked during the ground shaking. Furthermore, the dome itself would have deflected on one side by about 75 mm and also rotated. Note that similar movements of the dome were also reported following the last two major earthquakes that struck the region in 1949 and in 1965.

**Figure 3.1.3** Differential Movement between the Drum and Lower Masonry Portion of the Legislative Building in Olympia.

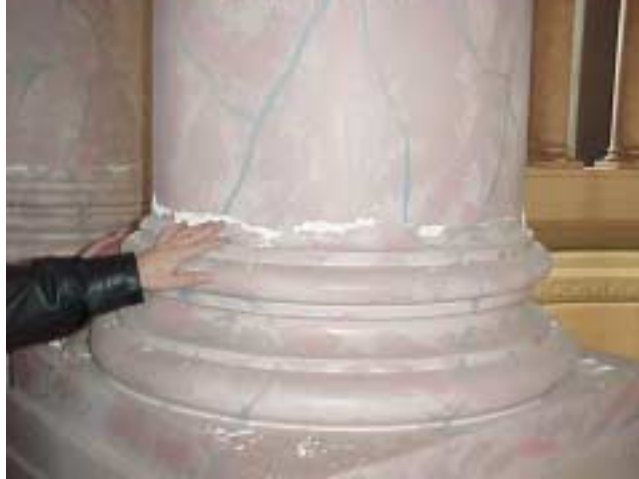
As a result of the movement of the drum and the dome, horizontal cracking of the architectural plaster occurred at the base of each interior masonry buttress, as shown in Fig. 3.1.4. At the time of writing, preparations were underway to investigate the structural condition of these interior buttresses that were believed to contain encased structural steel sections.

**Figure 3.1.4** Cracking of Architectural Plaster at the Base of an Interior Masonry Buttress of the Legislative Building in Olympia.

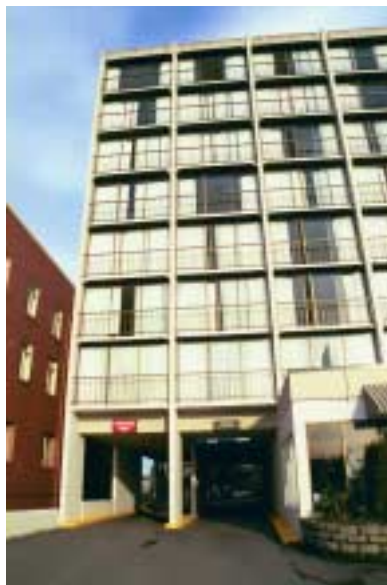
Figure 3.1.6 shows an elevation view of the west end of the Ramada Inn. This section of the building settled relative to the remainder of the structure. At the eighth floor level, this differential settlement was of the order of 20 to 40 mm. It is of interest to note that the two stairwells and elevator shafts were east of this section of the building. It was observed that the settlement initiated along a construction joint that was located in the floor slabs at each level of the building. Vertical differential movement at the construction joint in the eighth floor level slab was of the order of 8 to 10 mm, as shown in Fig. 3.1.7.

**Figure 3.1.6** Section of the Ramada Inn in Olympia Showing Evidence of Differential Vertical Movement at Each Floor Level.

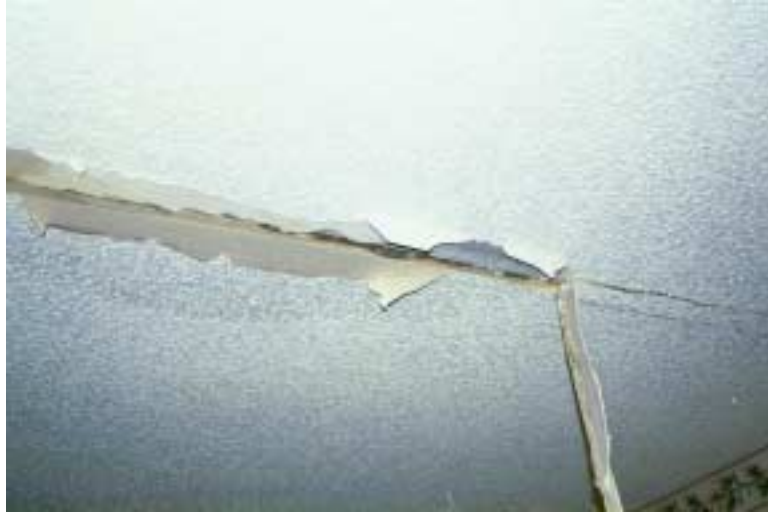
**Figure 3.1.7** Differential Vertical Movement in the Floor Slab on the Eight Floor of the Ramada Inn.

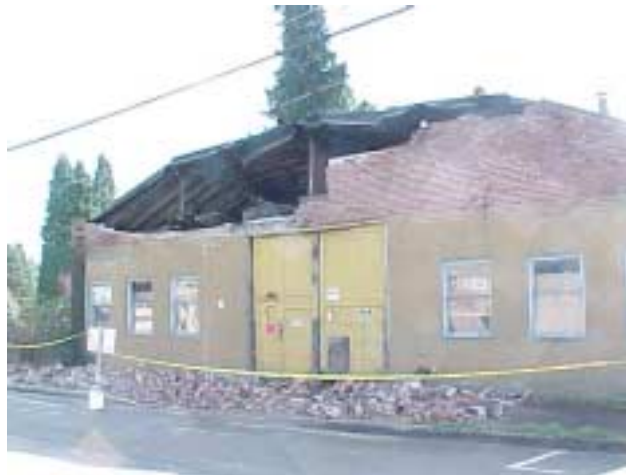
Figure 3.1.9 shows the out-of-plane failure of an old single-story masonry warehouse incorporating timber roof trusses on Second Avenue near Harrison Street in the city of Kent. The timber roof trusses were also damaged but did not collapse. A shear failure in one of the perimeter lintels was also observed, as shown in Fig. 3.1.10.

**Figure 3.1.9** Out-of-Plane Failure of an Old Single-Story Masonry Warehouse in Kent.

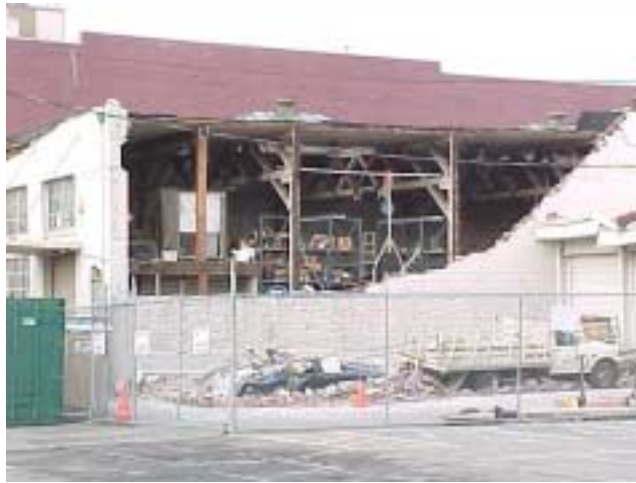
A substantial out-of-plane failure of an unreinforced masonry exterior wall occurred in a two-story masonry and wood structure on Utah Street in downtown Seattle, as shown in Fig. 3.1.11.

The interior timber trusses and columns performed well during the earthquake and continued to support the roof structure even after the failure of the exterior wall.

**Figure 3.1.11** Failure of Masonry Facade of a Two-Story Wood Building in Seattle.

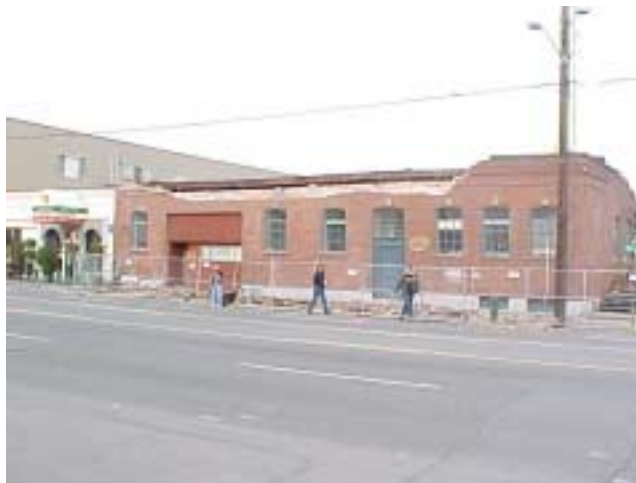
Another similar out-of-plane failure occurred at the Seattle Chocolate Factory in downtown Seattle. The west parapet of this one-story masonry building collapsed onto the street, as shown in Fig. 3.1.12. Also, the south masonry façade of the building collapsed onto and failed the wood roof covering the loading dock, as shown in Fig. 3.1.13.

**Figure 3.1.12** Collapse of the West Parapet of the Seattle Chocolate Factory in Seattle

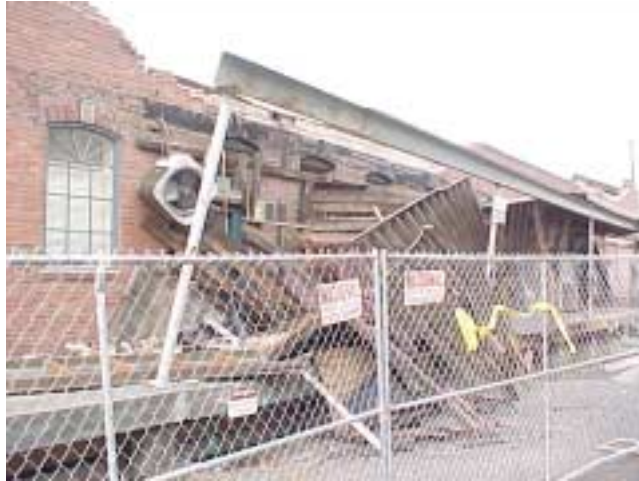
**Figure 3.1.13** Partial Collapse of the South Façade and Failure of the Loading Dock Canopy of the Seattle Chocolate Factory in Seattle.

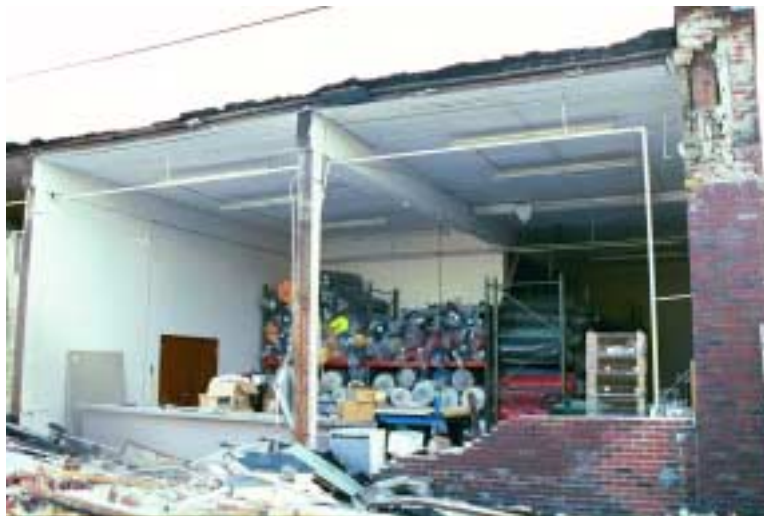
Figure 3.1.14 shows the complete collapse of an unreinforced brick wall along the whole north exterior face of the Acme Tool and Specialty Company Building, situated on First Avenue South in Seattle. The timber beams and columns remaining intact during the earthquake prevented collapse of the timber roof structure.

**Figure 3.1.14** Complete Failure of an Unreinforced Brick Wall along the North Face of the Acme Tool and Specialty Building on First Avenue South in Seattle.

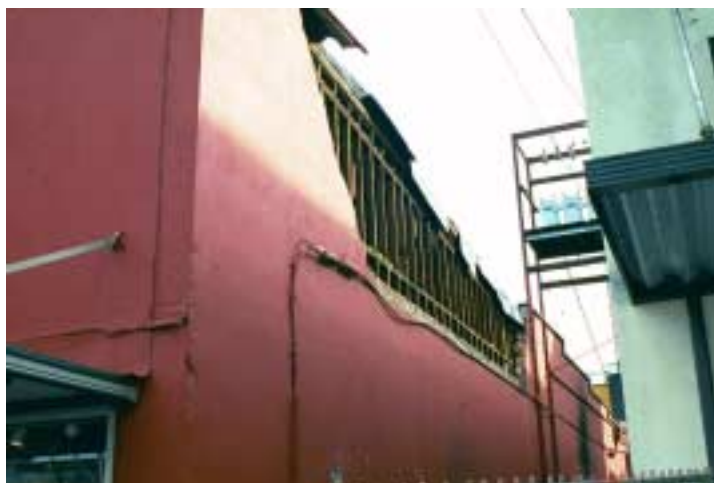
Figure 3.1.16 shows another example of an out-of-plane failure of an unreinforced exterior masonry wall in the Skookum Bay Outfitters Building at 518 Capitol Way South in Olympia. Again, the interior wood framing performed well during the earthquake and continued to support the roof even with partial collapse of the exterior wall.

**Figure 3.1.16** Partial Collapse of an Exterior Unreinforced Brick Wall in the Skookum Bay Outfitter Building at 518 Capitol Way South in Olympia.

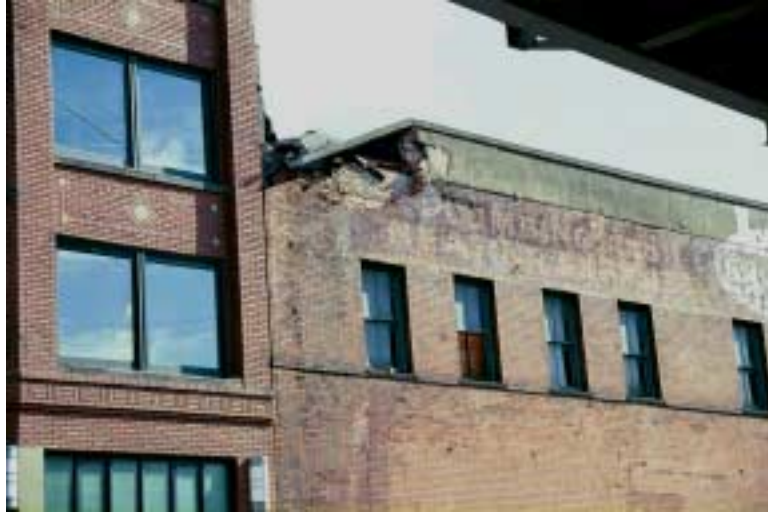
Damage from the pounding of adjacent closely spaced building with different roof levels was commonly observed in the Pioneer Square area of Seattle. Figure 3.1.18 shows the partial failure of the roof structure and brick façade of a building in the 500 block of First Avenue South in Seattle, which mostly likely resulted from pounding against the adjacent building. Figure 3.1.19 shows that the brick façade at the end of this building was forced out of plane along the full building height. Masonry anchors through the brick façade helped to prevent a larger out-of-plane deformation of the wall.

**Figure 3.1.18** Partial Roof Failure Resulting from Pounding of Adjacent Building in the 500 Block of First Avenue South in Seattle.

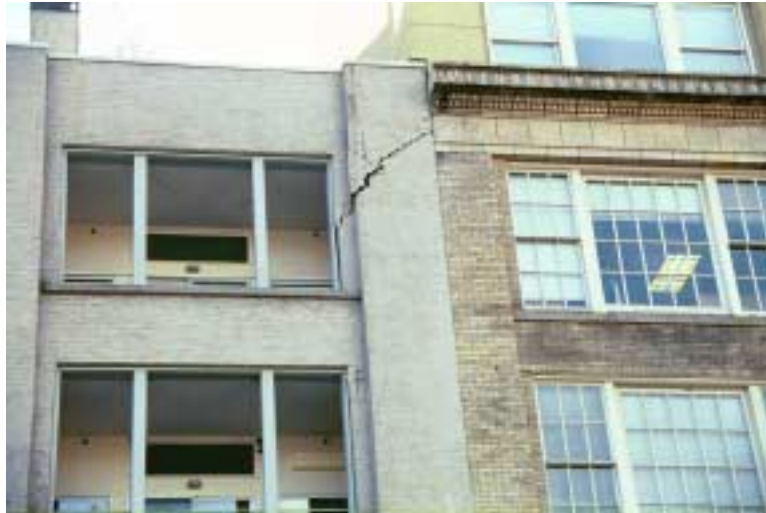
Another example of localized pounding damage, in the form of a shear crack, to a brick façade of a large four-story apartment building at 515 Occidental Avenue in Seattle is shown in Fig 3.1.20. The remainder of this building did not show any visual evidence of damage.

**Figure 3.1.20** Localized Pounding Damage to a Brick Facade of a Four-Story Apartment Building at 515 Occidental Avenue in Seattle.

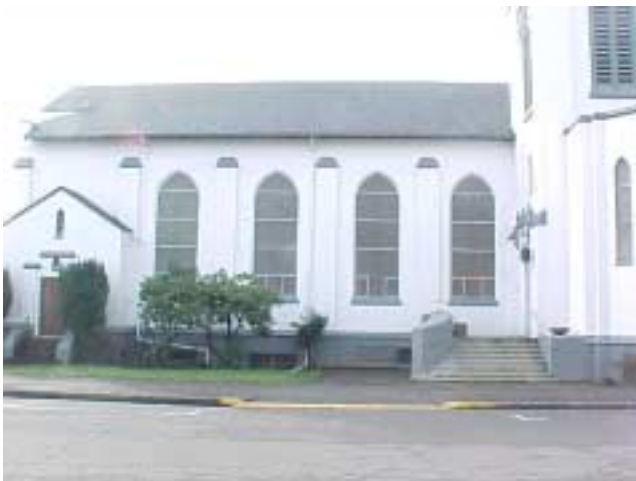
Significant in-plane cracking of masonry walls was also observed in several structures. One example of this occurred at the First Christian Church located on the corner of Seventh Avenue and Franklin Street in Olympia, as shown in Fig. 3.1.21. Diagonal cracking occurred between the large window openings and the re-entrant corners of the structure.

**Figure 3.1.21** In-plane Cracking of Masonry Walls of the First Christian Church in Olympia.

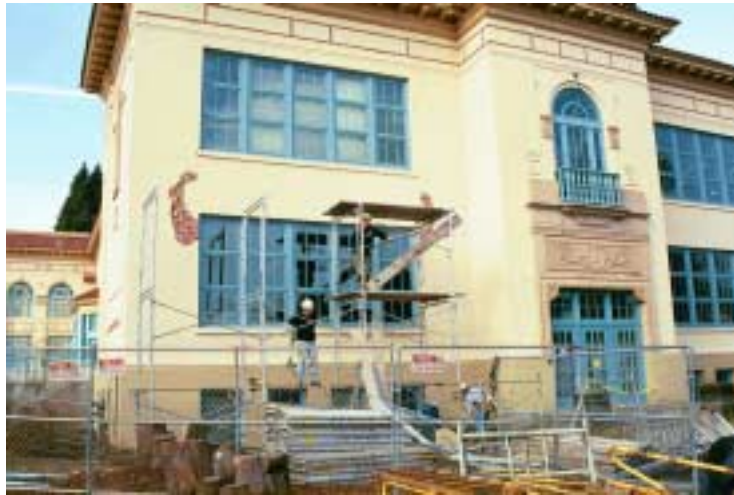
Another example of in-plane cracking of masonry walls occurred in the east wing of Lincoln Elementary School in Olympia, as shown in Fig 3.1.22. This damage caused the building to be yellow-tagged and forced relocation of the students to a nearby church facility until repairs are

**Figure 3.1.22** In-plane Cracking of Masonry Walls in the East Wing of Lincoln Elementary School in Olympia.

completed. As shown in Fig 3.1.22, repair to the structure was already underway at the time of this field reconnaissance.

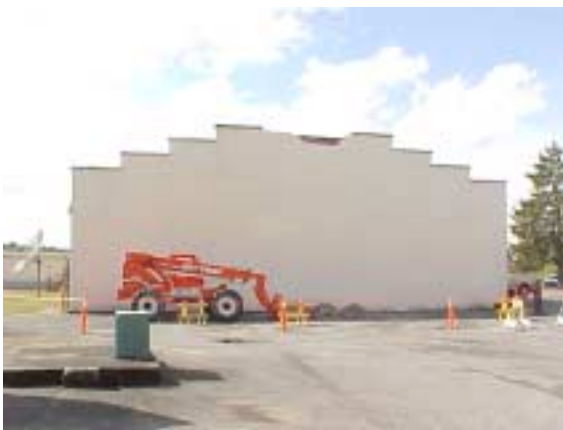
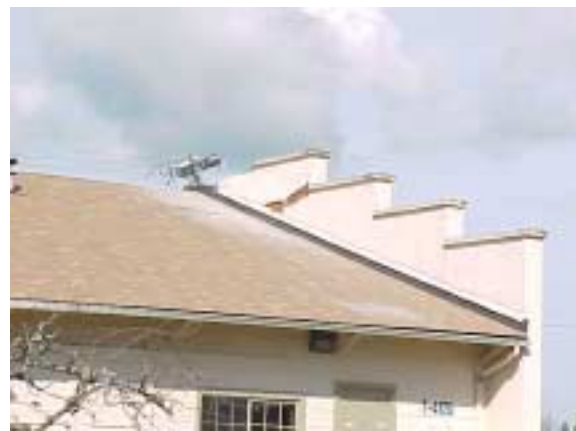
Failures of parapets were observed in numerous masonry buildings throughout Olympia and Seattle. In tallying damage to unreinforced masonry and brick-faced buildings, total or partial collapse of parapets was the most common type of visual damage observed during the field reconnaissance. One example of this is the failure of a step parapet in a two-story military dormitory in Fort Lewis, as shown in Fig. 3.1.23. Parts of the parapet fell onto the roof of the building and punctured it. The building also sustained water damage as a result of heavy rain that occurred the day after the earthquake.

**Figure 3.1.23** Failure of a Stepped Masonry Parapet in a Two-Story Military Dormitory Building in Fort Lewis.

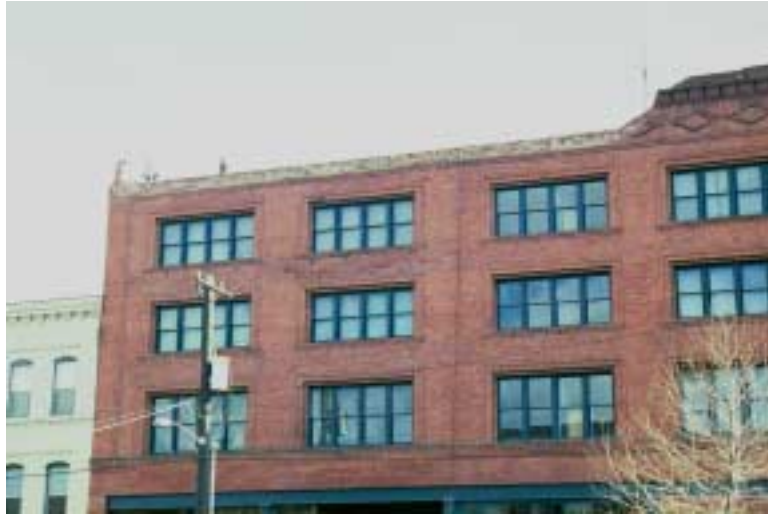
Another example of an unreinforced parapet failure is shown in Fig 3.1.24 for the building at 558 First Avenue South in Seattle. With this building three quarters of the parapet along the west face of the building collapsed to the street below during the earthquake.

**Figure 3.1.24** Collapse of an Unreinforced Parapet to the Building at 558 First Avenue South in Seattle.

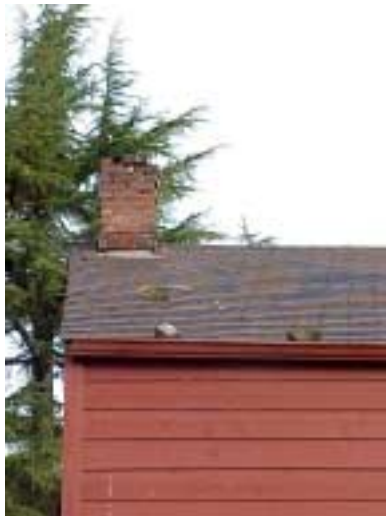
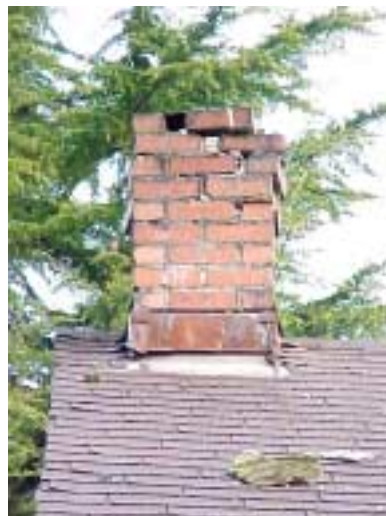
A number of unbraced chimney failures were observed in older residential wood frame buildings in Olympia. An example of chimney failure is shown in Fig. 3.1.25 for a three-story apartment building in Olympia.

**Figure 3.1.25** Chimney Failure in a Three-Story Wood Frame Apartment Building in Olympia.

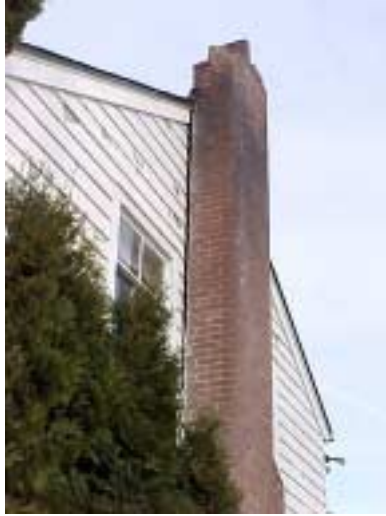
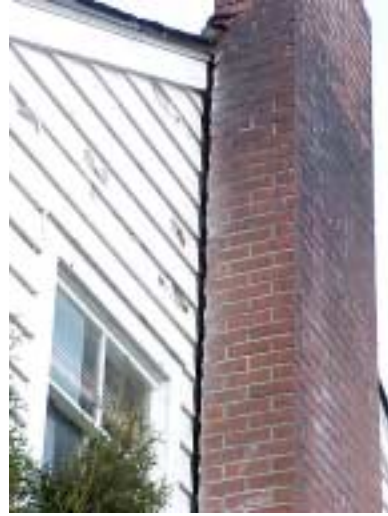
Figure 3.1.26 shows the failure of another chimney in a three-story wood frame house located at the corner of Tenth Avenue and Franklin Street in Olympia. The top part of the chimney above the roof collapsed to the ground, while the bottom part separated from the house over its entire height.

**Figure 3.1.26** Separation and Failure of the Chimney of a Three-Story Wood Frame House in Olympia.

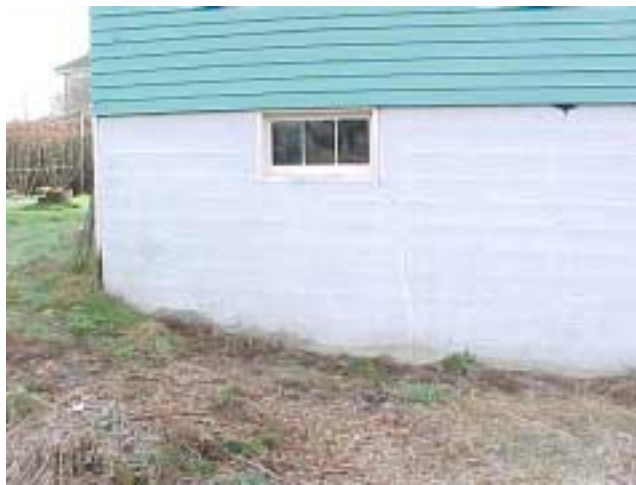
Another type of damage widely observed in wood frame houses in Olympia was the cracking of concrete or masonry foundation walls. The cracking often originated in the corners of basement window openings. An example of this is shown in Fig. 3.1.29 for a house near Franklin Street in Olympia.

**Figure 3.1.29** Cracking of the Concrete Foundation Wall of a Wood Frame House in Olympia.

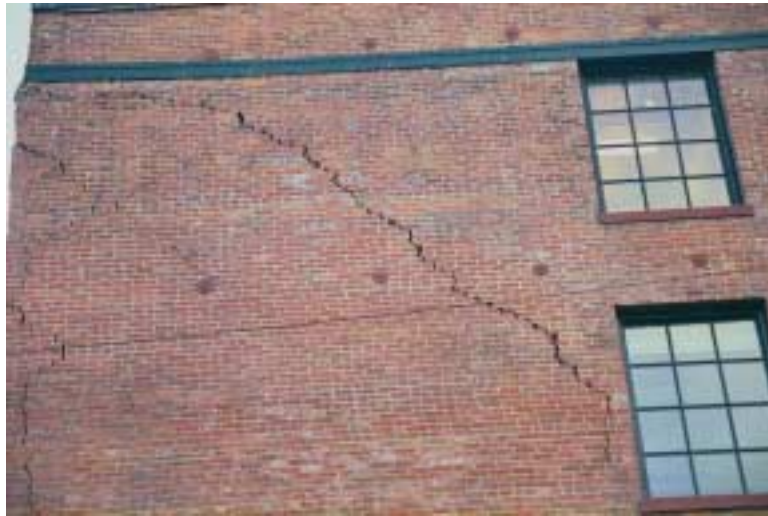
limited to in-plane diagonal cracking of the east corner of the north masonry wall, as shown in Fig. 3.1.34.

**Figure 3.1.34** In-plane Cracking of the North Masonry Wall of the Cobalt Group Building in Seattle.

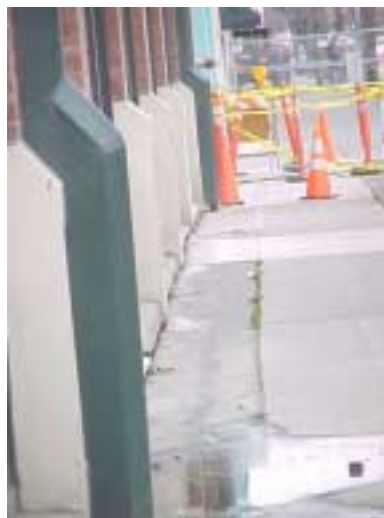
During the earthquake, the building experienced water damage in its basement as a result of a water main breaking. Evidence of rocking of the base of the building in the east-west direction was also observed, as shown in Fig. 3.1.35.

**Figure 3.1.35** Separation between West Facade of the Cobalt Group Building in Seattle and the Sidewalk Showing Evidence of Rocking of the Building in East-West Direction.

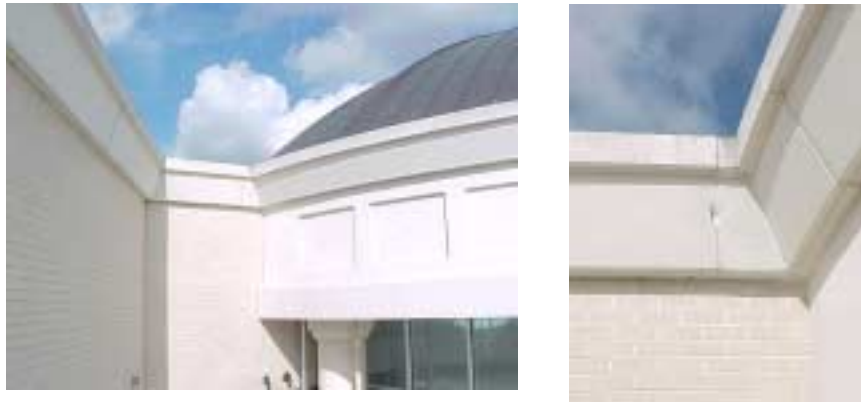
Figure 3.2.3 shows evidence of pounding between the rotunda and the parapet of one of the adjacent wings. The vertical cracking of the parapet was also visible inside the building.

**Figure 3.2.3** Evidence of Pounding at Kent Regional District Center.

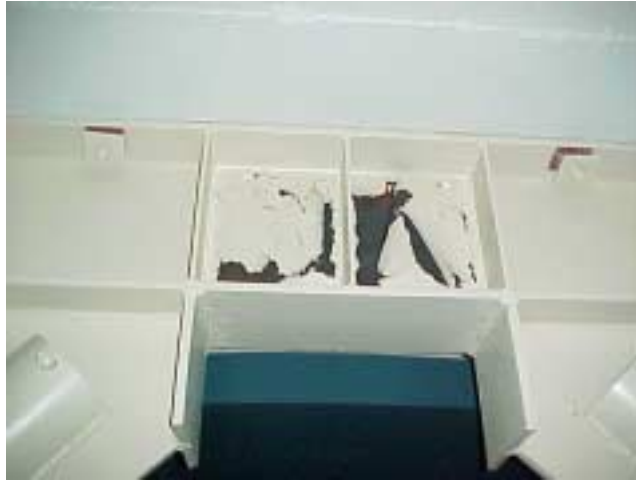
**Figure 3.2.6** Yielding of a Chevron Eccentrically Braced Frame in the East-West Direction of the Starbucks Headquarter in Downtown Seattle.

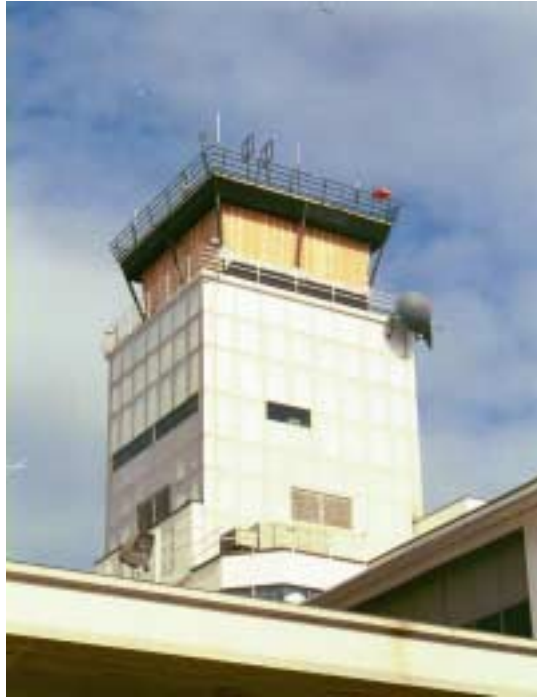
**Figure 3.2.7** Damage to the Existing Sea-Tac Air Traffic Control Tower.

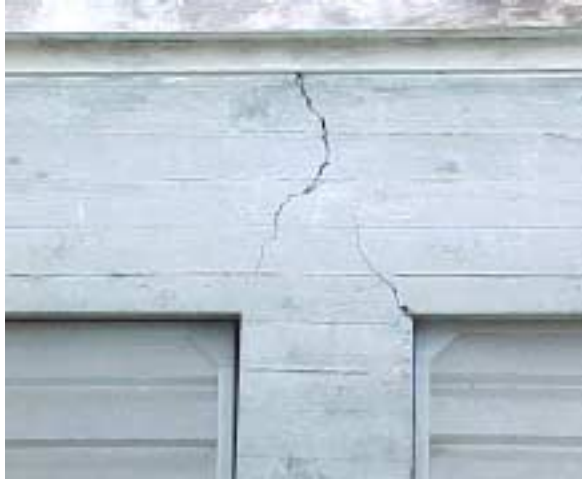
Figures 3.3.5 and 3.3.6 show the damage suffered by a concrete detached garage unit located on Franklin Street in Olympia. The concrete frame in the open front suffered cracking in the beam-to-column connections. One existing horizontal crack expanded during the earthquake, causing the column to lean sideways, thereby jamming the garage door.

**Figure 3.3.6** Cracking in Beam-to-Column Joints of a Concrete Garage Unit on Franklin Street in Olympia.

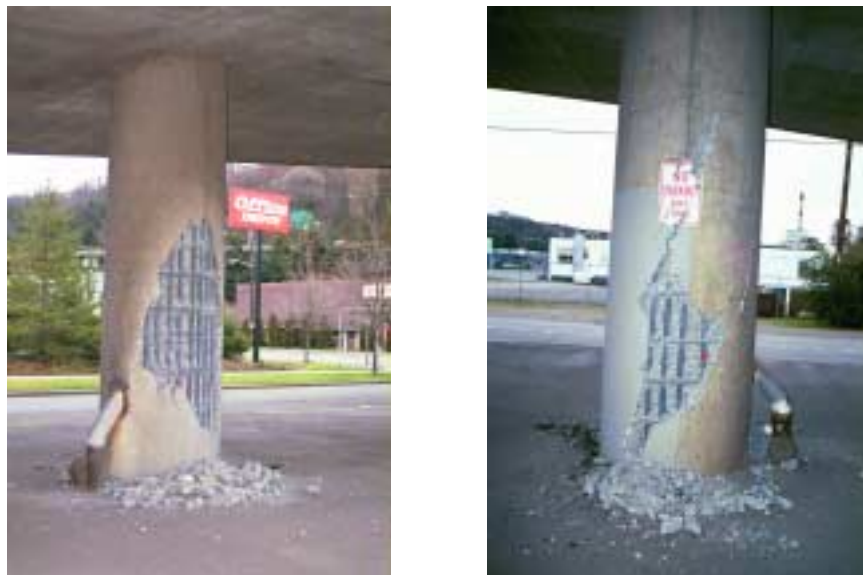
An illustration of the damage that occurred in the westernmost column is presented in Fig. 4.1.2. As shown by the diagonal cracks and the spalled concrete, a substantial shear force developed in this column. The location of the damage relative to the column implies that longitudinal bridge motion was the major contributor to the damage. Evidence of longitudinal displacement is given by fresh scrape marks at a joint in the handrail, as shown in Fig. 4.1.3. Furthermore, the south roller at the west end of the bridge is permanently displaced from its intended relaxed position, as shown in Fig. 4.1.4

**Figure 4.1.2** Cracking and Spalling of Concrete in Holgate Bridge Column.

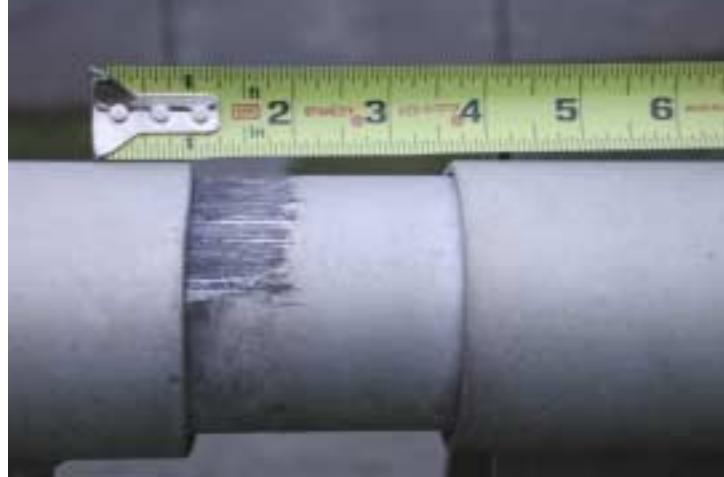
**Figure 4.1.3** Slipping of Handrail on Holgate Bridge.

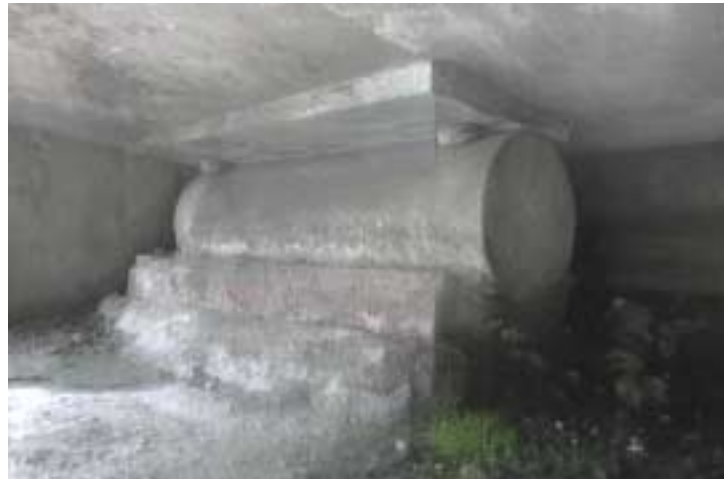
**Figure 4.1.4** Displaced Roller on West End of Holgate Bridge.

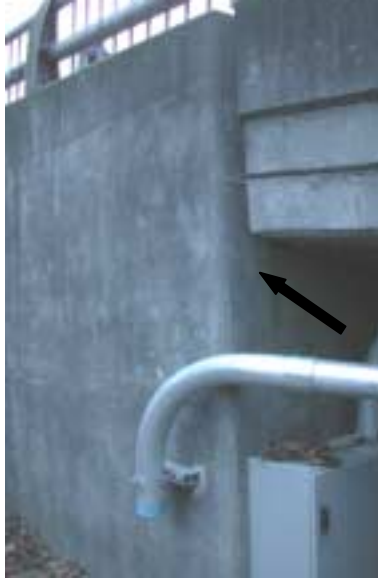
Evidence of transverse motion given by cracking in the abutment is shown in Fig. 4.1.5. Although the abutment damage is minor, it is apparent that the superstructure impacted the abutment at some instance during the earthquake.

**Figure 4.1.5** Cracked Abutment on East End of Holgate Bridge.

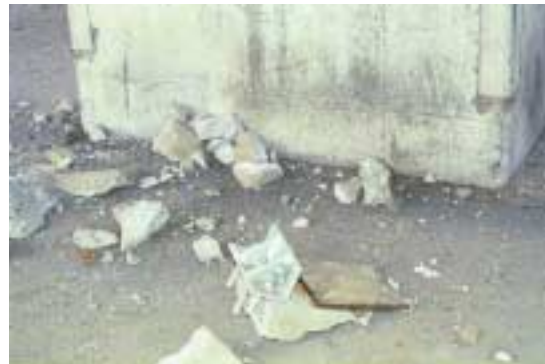
**Figure 4.2.4** Damage to Catchers.

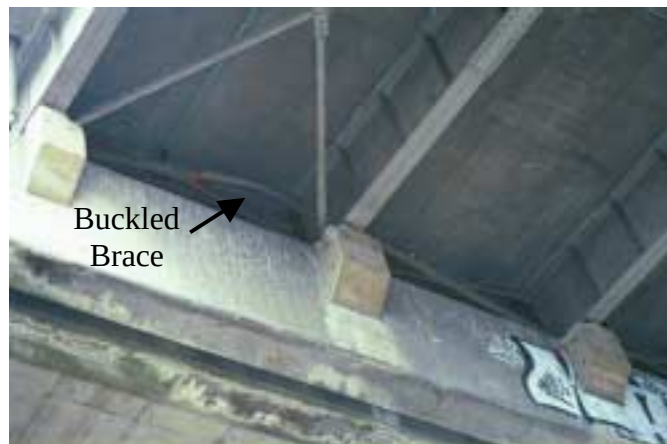
**Figure 4.2.5** End Diaphragm with Buckled Braces in Bent 25.

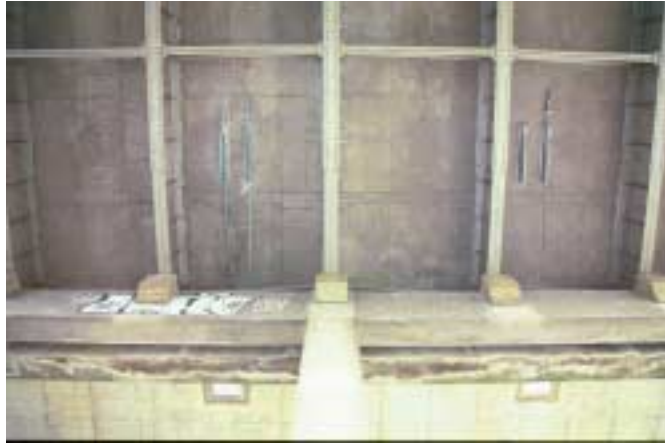
**Figure 4.2.6** Damage to Restrainers.

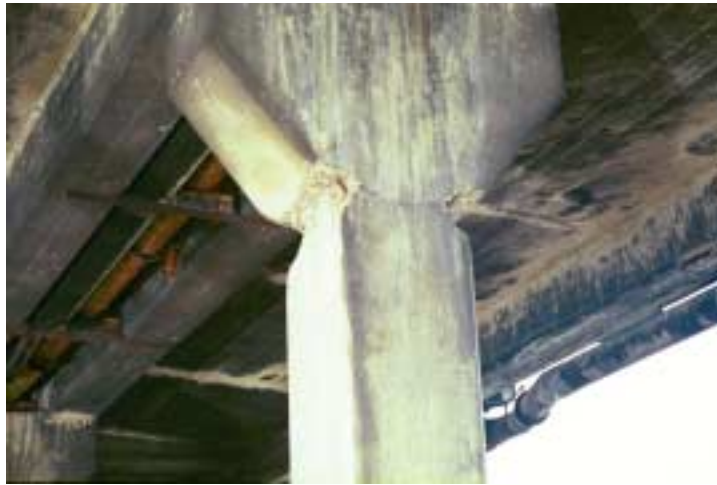
**Figure 4.4.3** Concrete Spalling at the Base of Column Flare.

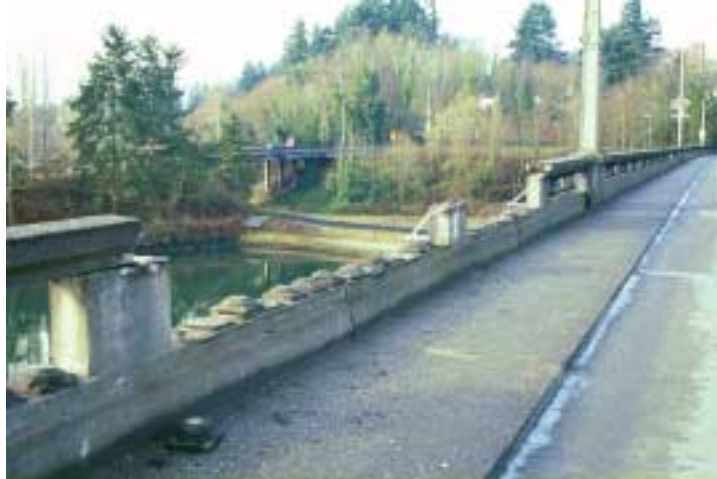
**Figure 4.4.5** Failure of a Section of Pedestrian Handrail.

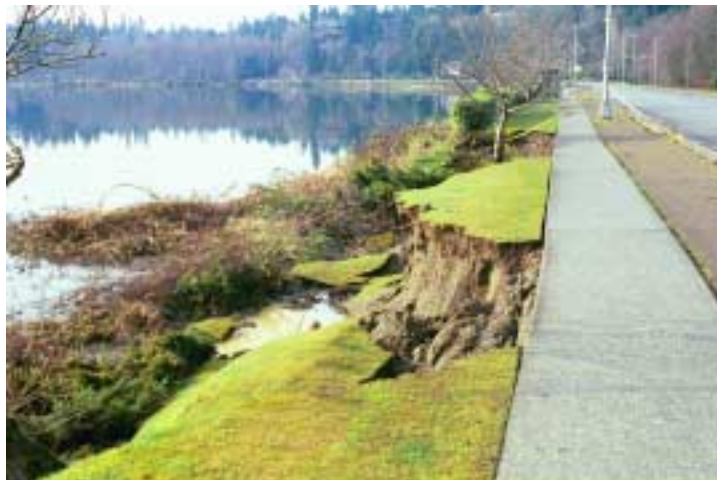
**Figure 4.4.6** Soil Failure along the Shore of Capitol Lake.

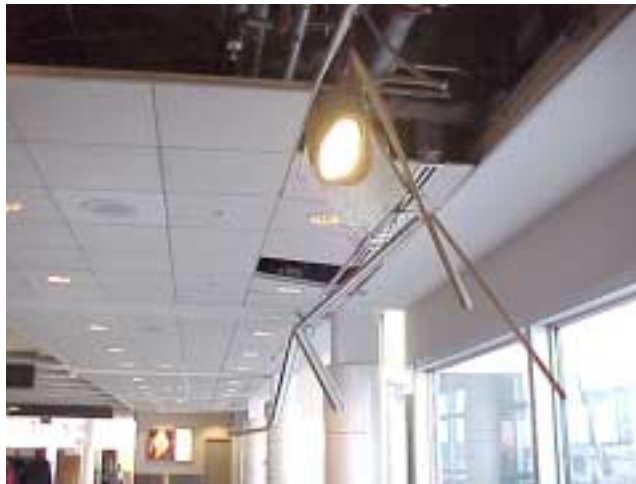
**Figure 5.1.1** Partial Failure of a Suspended Ceiling at Sea-Tac Airport.

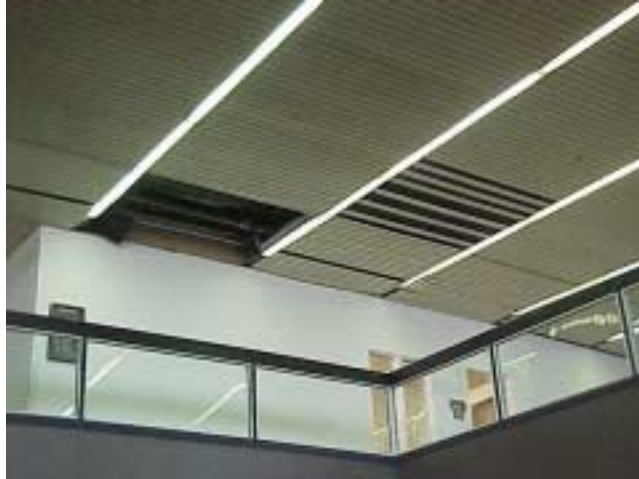
**Figure 5.1.2** Partial Failure of a Metal Suspended Ceiling at Sea-Tac Airport.

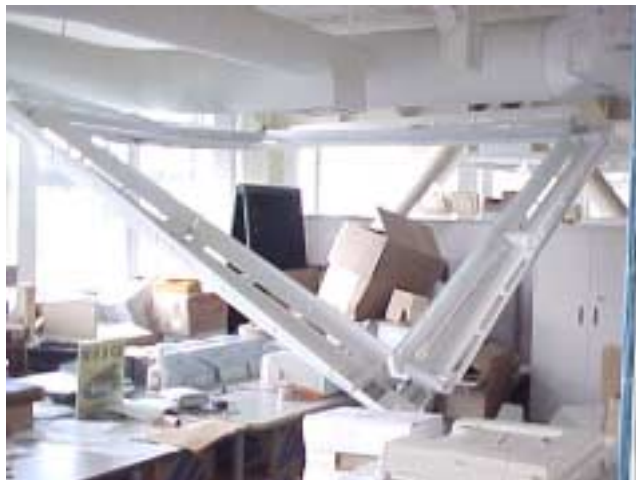
**Figure 5.1.3** Failure of Suspended Lighting Fixtures in Starbucks Headquarters in Seattle.

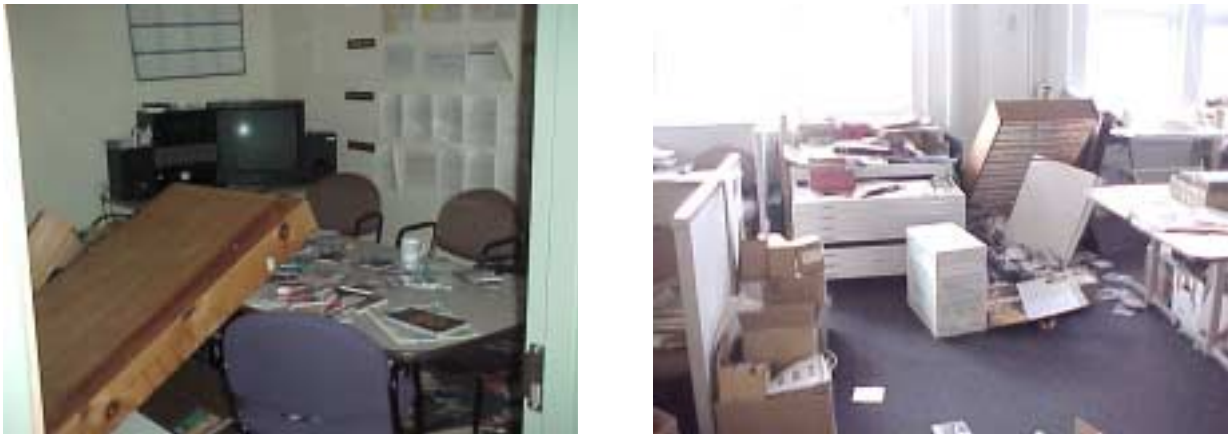
**Figure 5.1.4** Damage Caused by Unanchored Furniture Items and Building Contents in Starbucks Headquarters in Seattle.

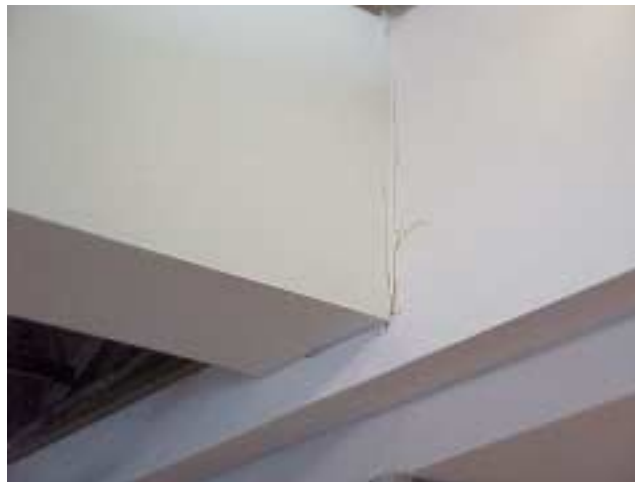
**Figure 5.2.1** Cracking of Drywall Finish in a Beam-to-Wall Connection at SeaTac Airport.

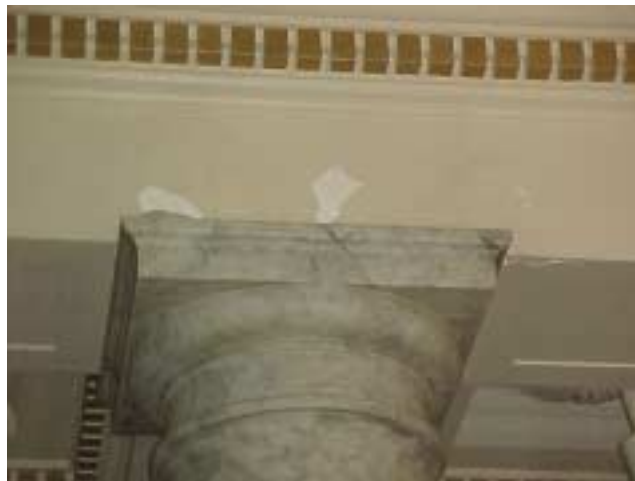
**Figure 5.2.3** Spalling of Plaster in Legislative Building in Olympia.

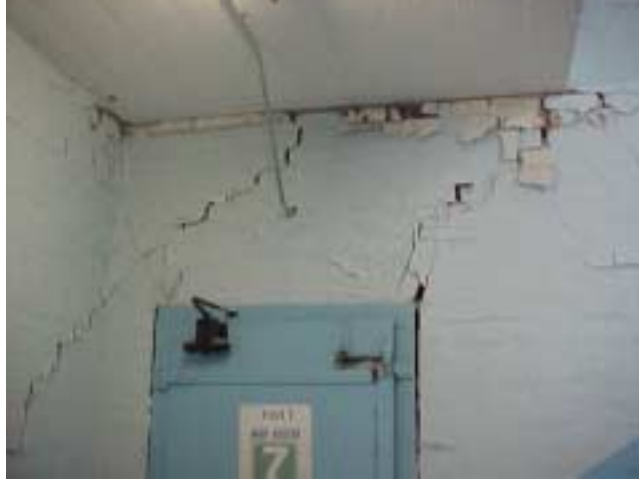
**Figure 5.2.6** Severe Cracking of Masonry Stairwells in Starbucks Headquarters in Seattle.

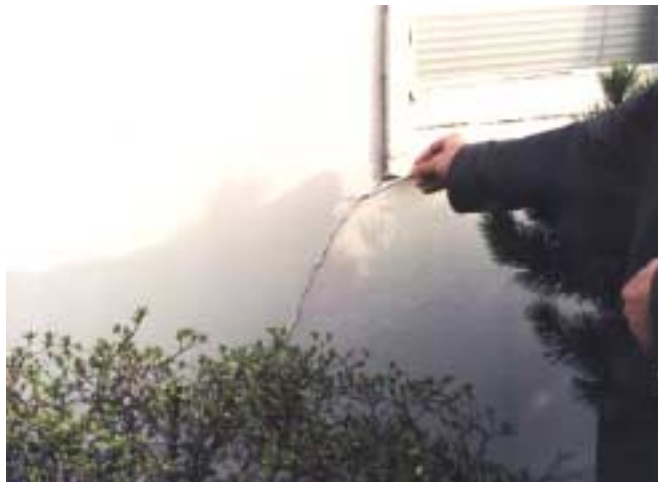
**Figure 5.3.1** Diagonal Cracking of Stucco between Window Openings in a Three-Story Apartment Building in Olympia.

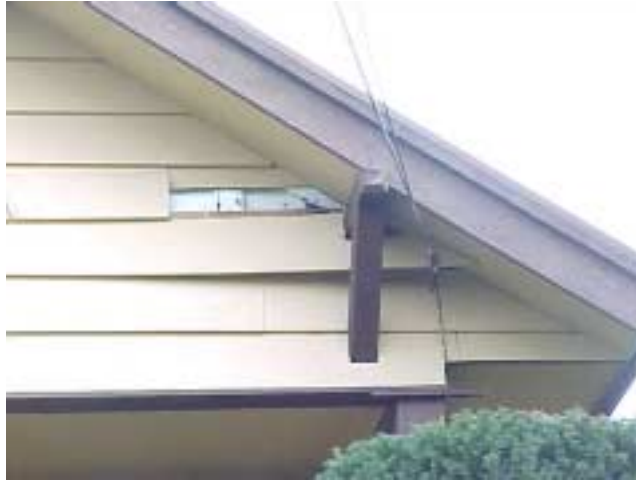
**Figure 5.3.2** Damage to the Siding Boards on a Wood Frame House in Olympia.

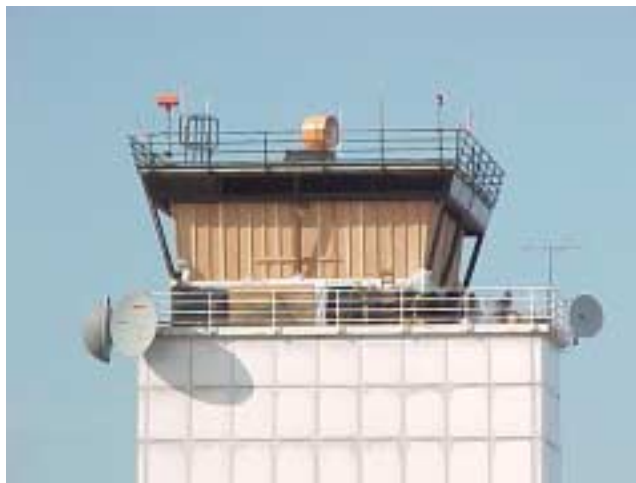
**Figure 5.4.1** Control Tower Shattered Windows Boarded with Plywood at Sea-Tac Airport.

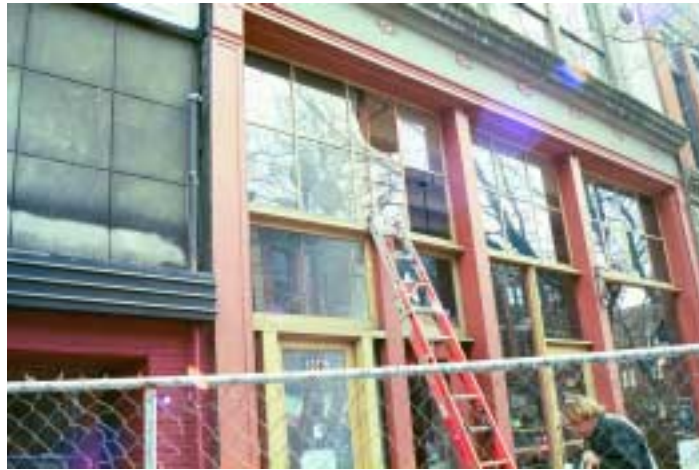
**Figure 5.4.2** Replacing Broken Windowpanes in the Pioneer Square Area of Seattle.

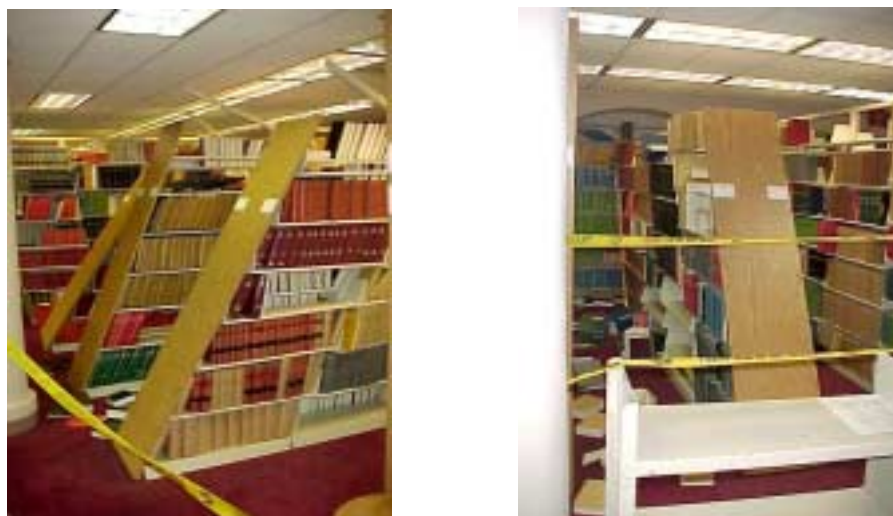
**Figure 5.5.1** Failed Bookshelves in the Main Library of the Temple of Justice Building in Olympia.

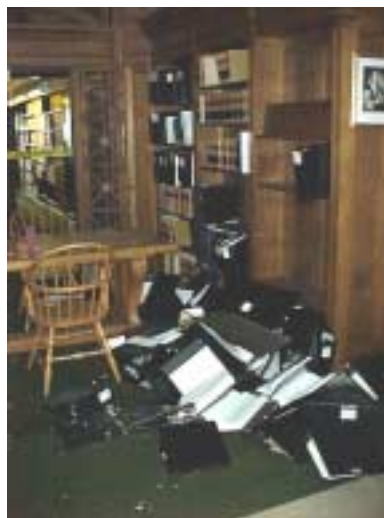
**Figure 5.5.4** Fallen Books from Massive Wooden Shelves in the Law Library of the Temple of Justice Building in Olympia.

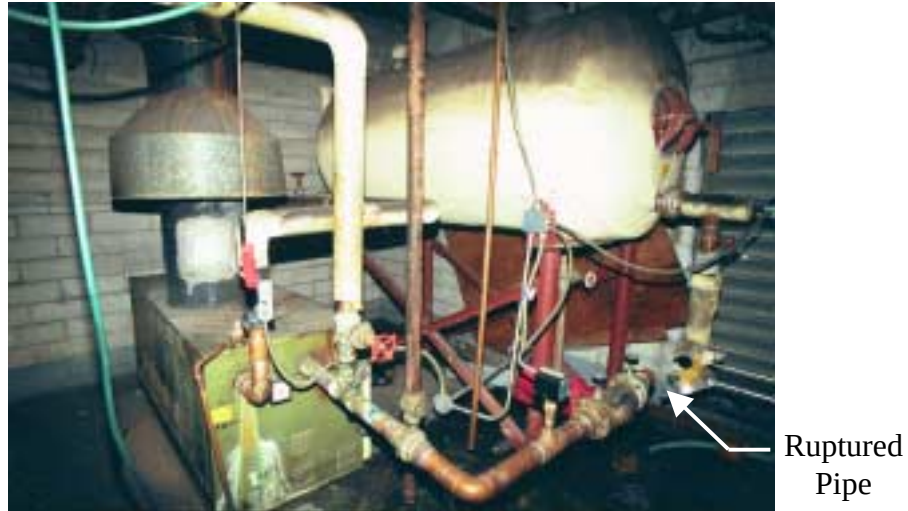
The Ramada Inn also sustained water damage from a ruptured supply line to a large water tank in the mechanical room on the roof of the building. This damage is discussed further in Section

**Figure 5.6.1** Rupture of the Supply Water Line to a 3000 Liter Storage Tank in the Roof Top Mechanical Room of the Ramada Inn in Olympia.
