**A report of the collision  
that occurred on 8 January 1991  
at Cannon Street Station**

London: HMSO

I report for the information of the Secretary of State for Transport in accordance with the direction dated 14 January, 1991 the result of my Inquiry into the collision of a passenger train with the buffer stops at the end of one of the platforms at Cannon Street Station, London, on Tuesday 8 January, 1991.

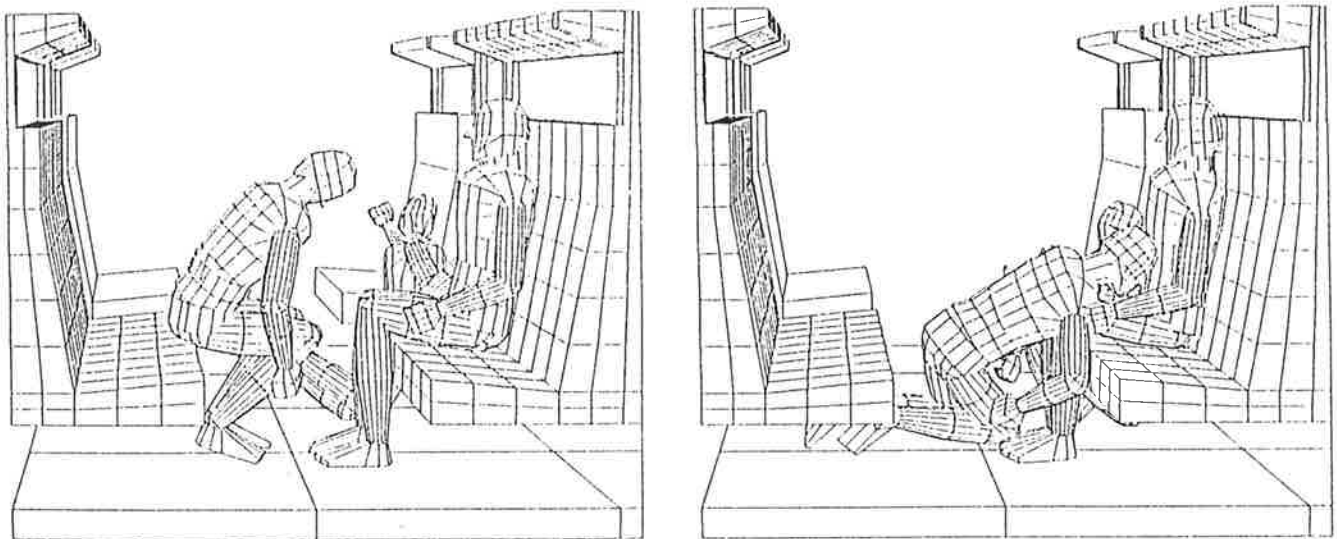
**Figure 6** Five mile/h impact

194 With the standing passenger's knee joints rigid during a 5 mile/h impact, the model's behaviour was similar to the basic case but as his legs do not bend when he falls over, the way in which he fell and how he struck the seats was different. However, with a more open stance the standing passenger did not fall and no significant force was generated at his grip of the luggage rack.
