Consultancy Services for Development of Disaster Risk and  
Early Warning Systems in Ghana

## **Risk Profiles of Hotspots in the Pilot Districts**

Technical Report

UNDP Ghana

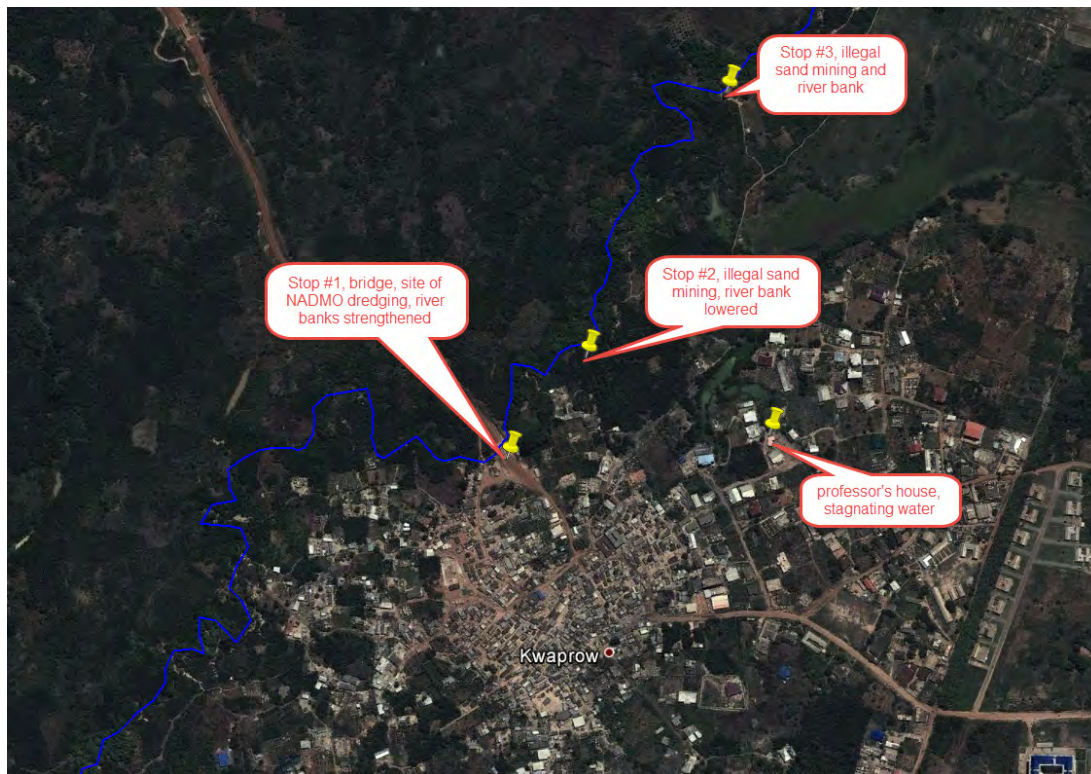
Figure 13. The visited locations within the hotspot Kwaprow.

The second and third spot visited showed clear evidence of sand mining in the river bed. This activity risks to change the river's course in some spots and poses a significant cave-in risk to the sand miners who often work under overlying topsoil layers. The sand mining does seem to have an effect on the river's course but the effect on the flooding seems to be doubtful. Increased sedimentation however can cause a reduction in discharge capacity.

The fourth site we visited showed how the natural drainage system of this wetland was blocked by construction. Unsufficient drainage capacity leads to a prolonged presence of flood waters. This causes problems to the foundation of houses (Figure 18) but also poses a health risk (cholera, mosquitoes etc.) and according to our spokesman even crocodiles. A restoration of the local drainage capacity and construction of new drainage systems seems necessary to alleviate the problems in the area. Our local expert from the University of Cape Coast (Dr Nyarko) has already done some model studies to determine what type of new drainage system would be able to take on this task.

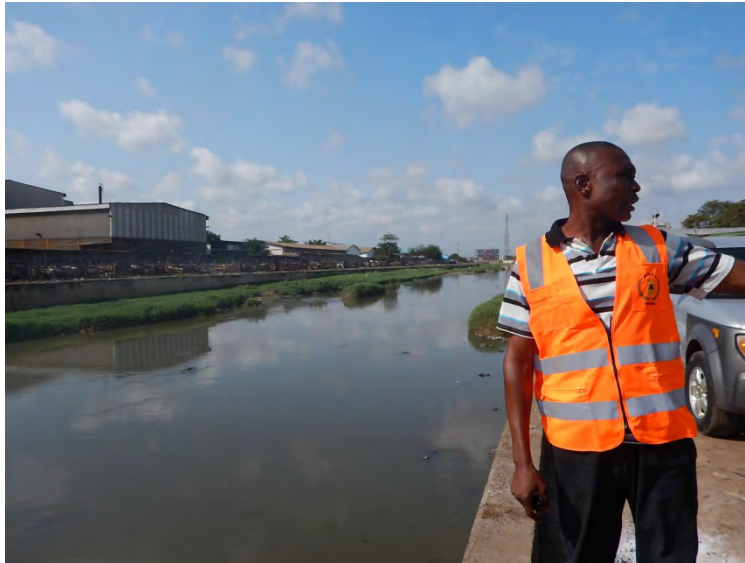
Figure 31: Odaw drain in Odawna area

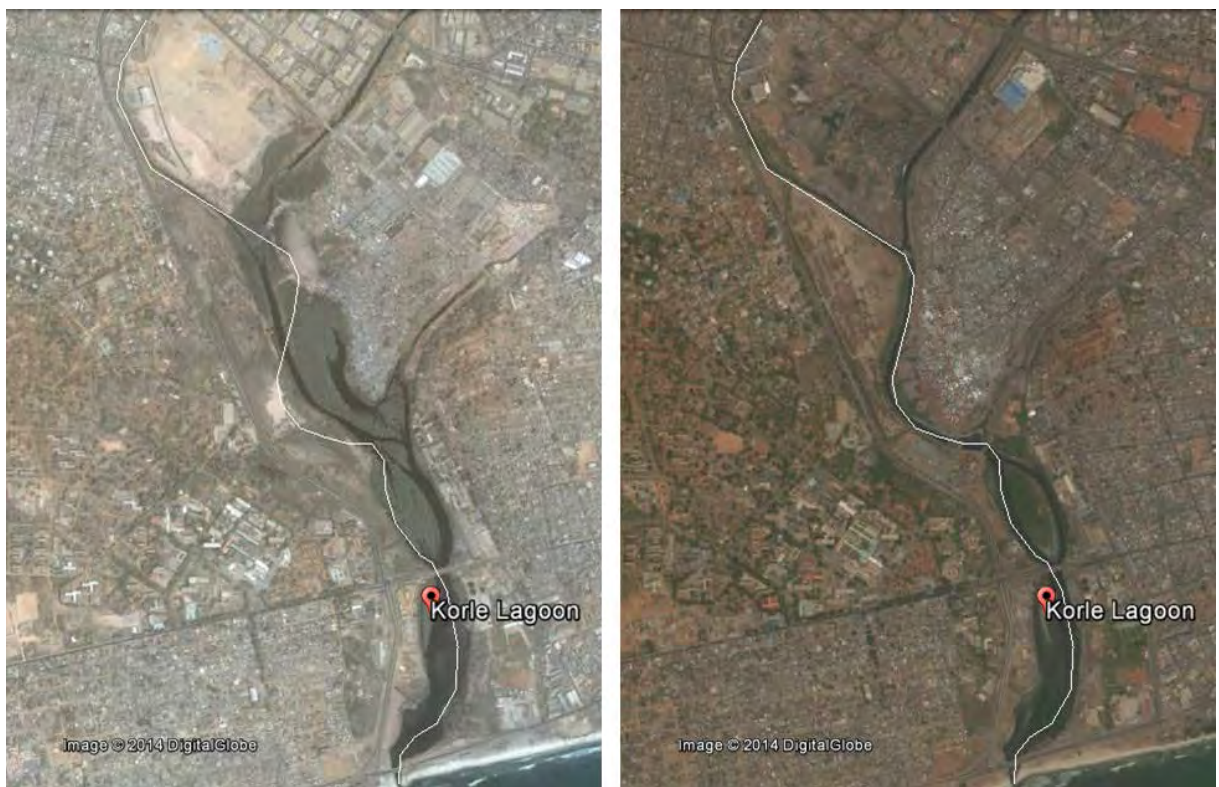
Urbanization of Accra in general and the areas around the Odaw drain specifically has increased strongly over the past decade. Figure 33 shows Google Earth based satellite images from the year 2000 and 2013 for the same location where the Odaw drains into the sea. The white line shows the channel in 2014. Over the past decade the Odaw has become more canalized: straighter and narrower. The floodplain areas have largely been deforested and developed. This results in fast runoff, limited water storage and less draining capacity.

Figure 33: Effects of urbanisation along the Odaw drain, satellite imagery from 2000 (left) and 2010 (right). Source: Google Earth

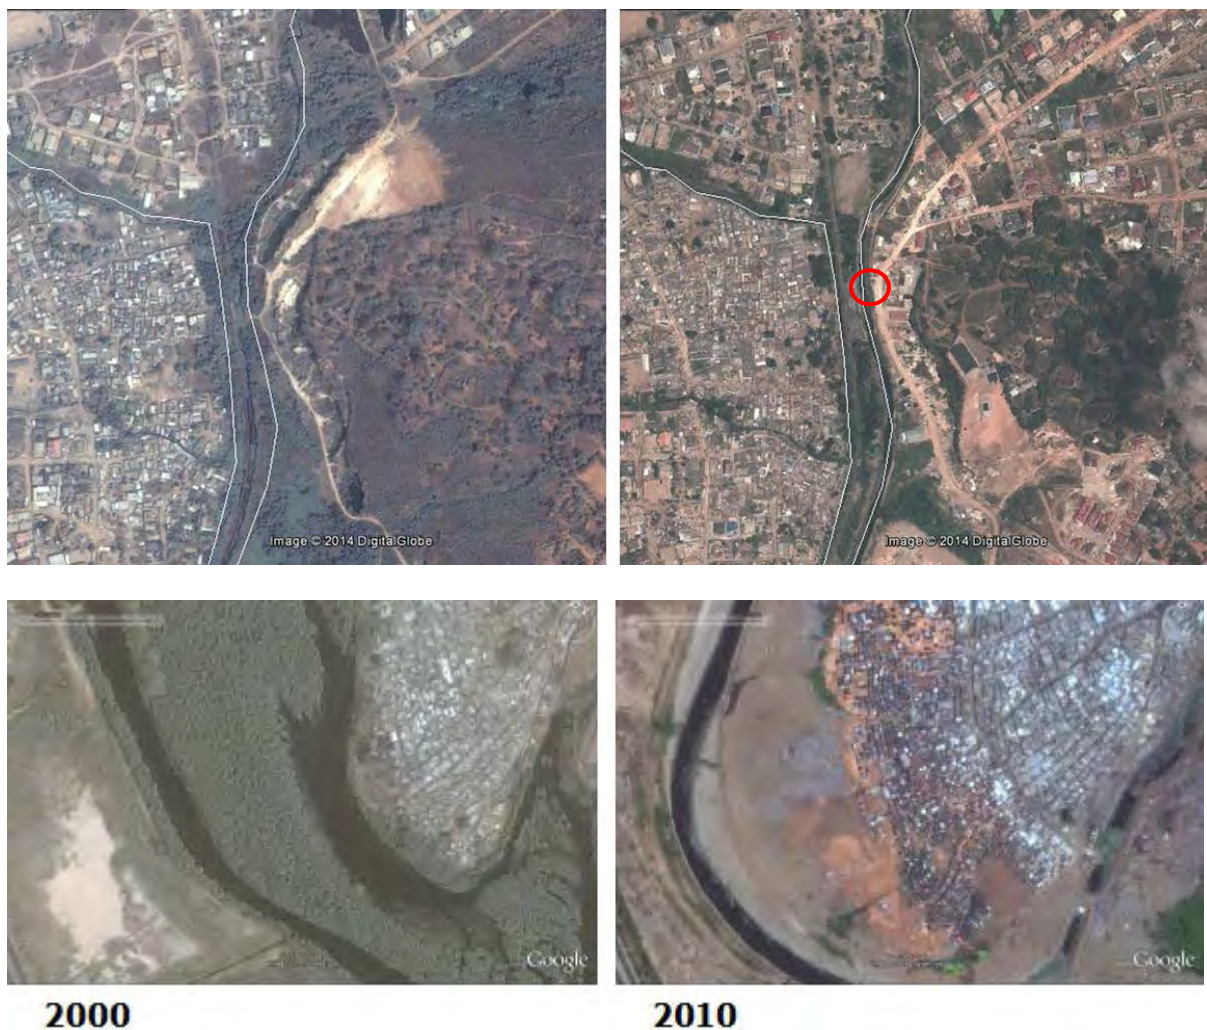
Figure 37 illustrates increased vulnerability in the Alogboshie area and Korle Lagoon; increase of urbanization is clearly visible.

Figure 37. Changes in urbanisation in Alogboshie area (above) and Korle Lagoon area (below).

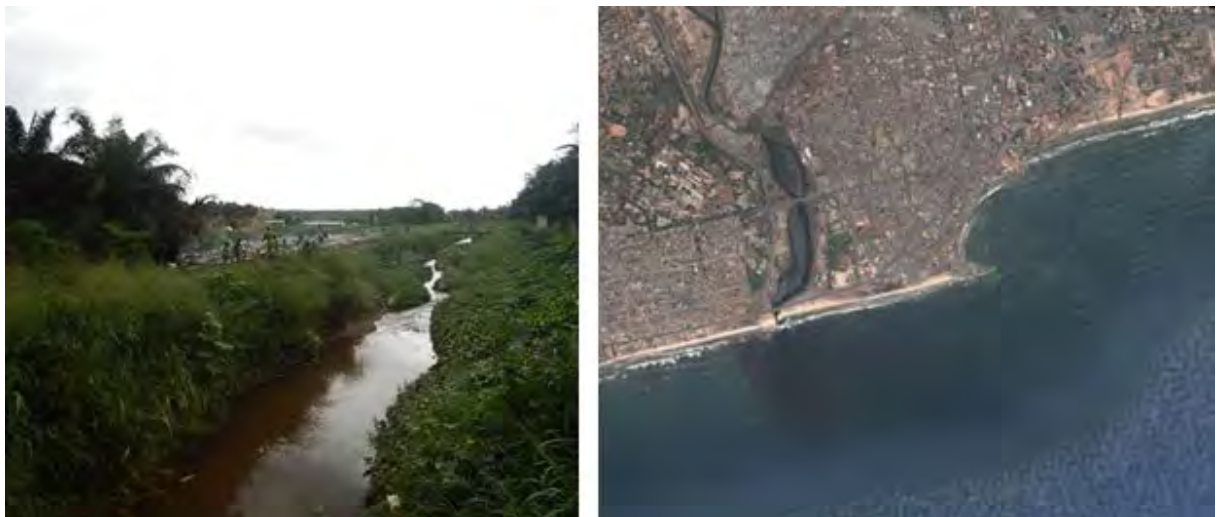
The current project does not include environmental risks, although these could be quite important in some cases. When visiting the Accra hotspots, environmental risks are visible everywhere. During our visit to Alogboshie we came across a waste disposal location along the Odaw drain. When the Odaw is flooded, the waste is washed away as well. The southern part of the Odaw drain is even worse, and famous for its environmental disasters. Figure 39 shows the waste disposal in Alogboshie on the left. The right side picture shows a dark plume flowing into the sea and spreading along the coast.

**Figure 39: Environmental risks in Accra**

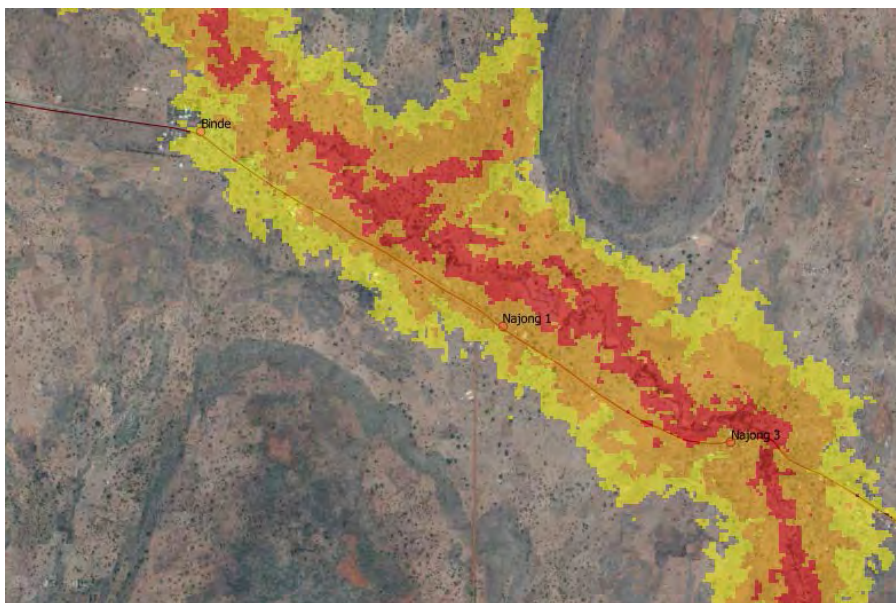
The hotspots are located in the catchment of one of the north-south tributaries. The area of the hotspots has been marked with a circle on the flood hazard map (Figure 41). The cause of the recent floods in the hotspot area is a road that is constructed parallel to the stream. The road is constructed as a dam and has several gullies and culverts to drain

the adjoining area. However, the western side of the road has hardly any drains, and the ones that exist, are overgrown. Culverts do not exist. This means that all the water coming from the south-western side which normally drains to the stream on the north-eastern side is blocked by the road, causing the south-western side of the area to flood and creating an area where the water is stored. Once the water level rises above the level of the road, the road and the downstream areas are flooded as well. The locals say that the road was rehabilitated around 2012 after which the problems started. Also, the contractor that built the road extracted the soil needed for road construction from nearby lands, creating drains and low lying areas where water accumulates. The house of one of the local farmers was situated at the end of such a man-made drain. The house was washed away in the flood of 2013.

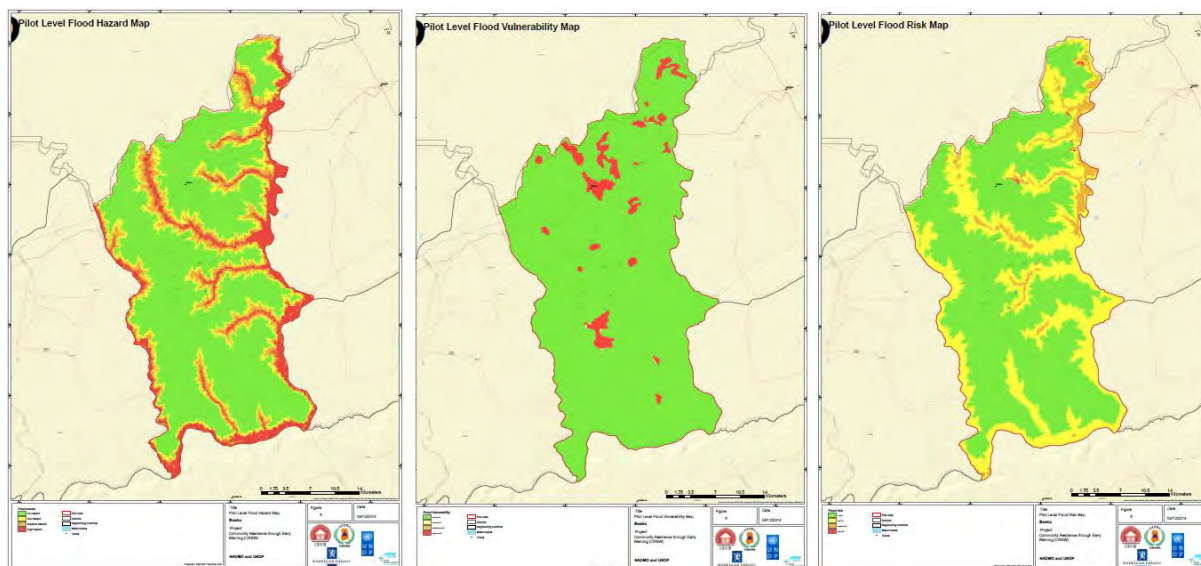
**Figure 48: Flood hazard (left), flood vulnerability (middle) and flood risk (right) in the Bawku-West district**

The flood hazard, vulnerability and risk are presented in Figure 48. The hotspot areas are located in the high risk zones in the district.

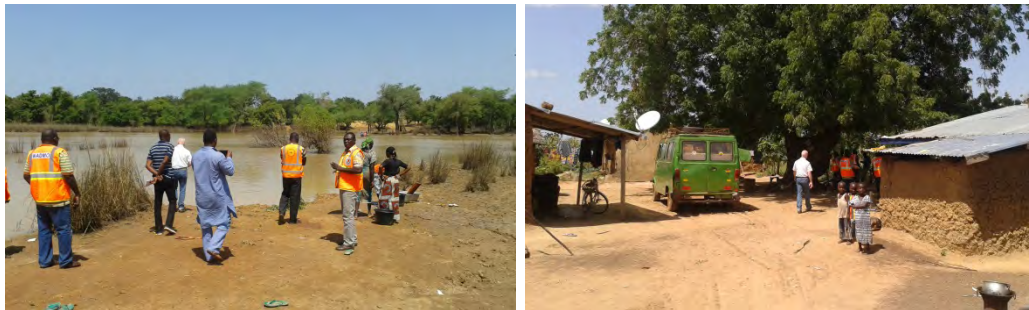
Figure 51: Bagri Zongo, along the Black Volta River (left) and fishing community (right)

This community along the Black Volta is located in an area which suffers from regular flooding from the river. The water level in the river can rise several meters and floods the areas on either side to a total width of up to 1 km during the months August-October. The flood waters reach the community's settlement, where some 60 houses are flooded regularly. Sometimes houses collapse. The community will not move away from their location as they want to protect their fishing rights. The people accept the risk that their houses get flooded.

Another problem is caused by the people crossing the river in small boats to cross from Ghana to Burkina Faso and back. Almost every year people drown while crossing the river during high flows.

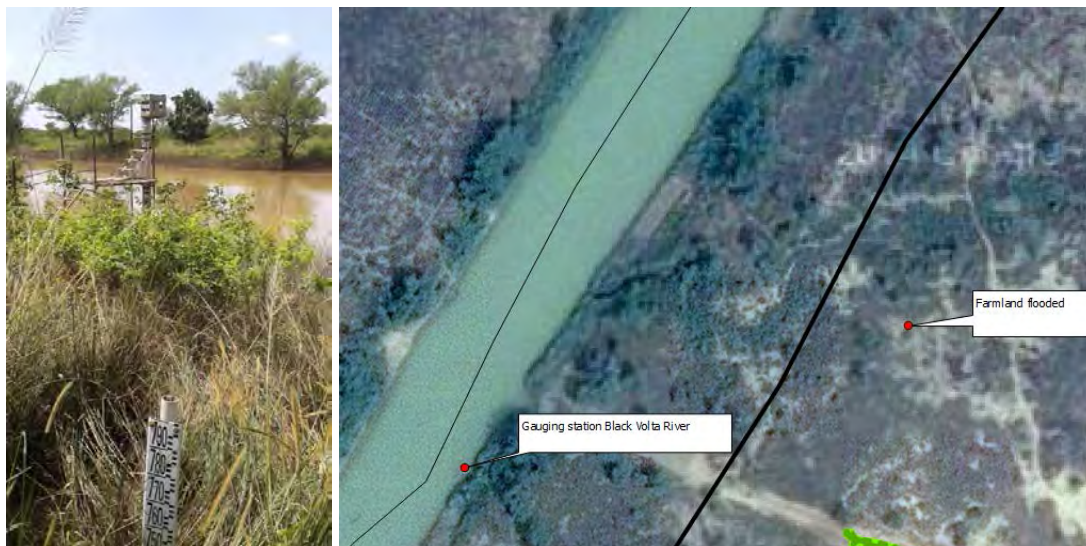
Figure 53. Dikpe: Abandoned gauging station Black Volta (left), Overview (right)

An abandoned river gauging station was found on the Black Volta River in this area (see Figure 53).

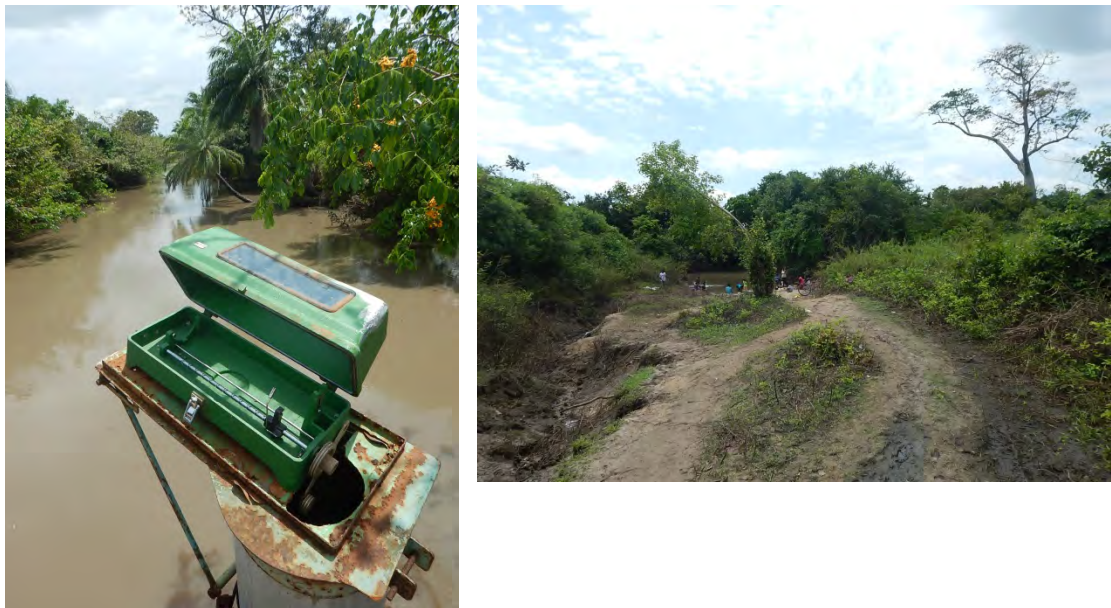
Figure 56: Gauge recorder at the Tordzi river (left), path to the river near Wute (right)

The village of Wute is located close to the road from Ho to Akatsi. Flooding occurs from the Tordzi River. The village was recently flooded according to the residents. However, the frequency of flooding seems low. Water overflows the river banks occasionally, but rarely (every 10 - 20 years) reaches the village. Hardly any houses are located between the river banks and the village, only some agricultural lands. A shed recently got flooded and has been rebuilt.

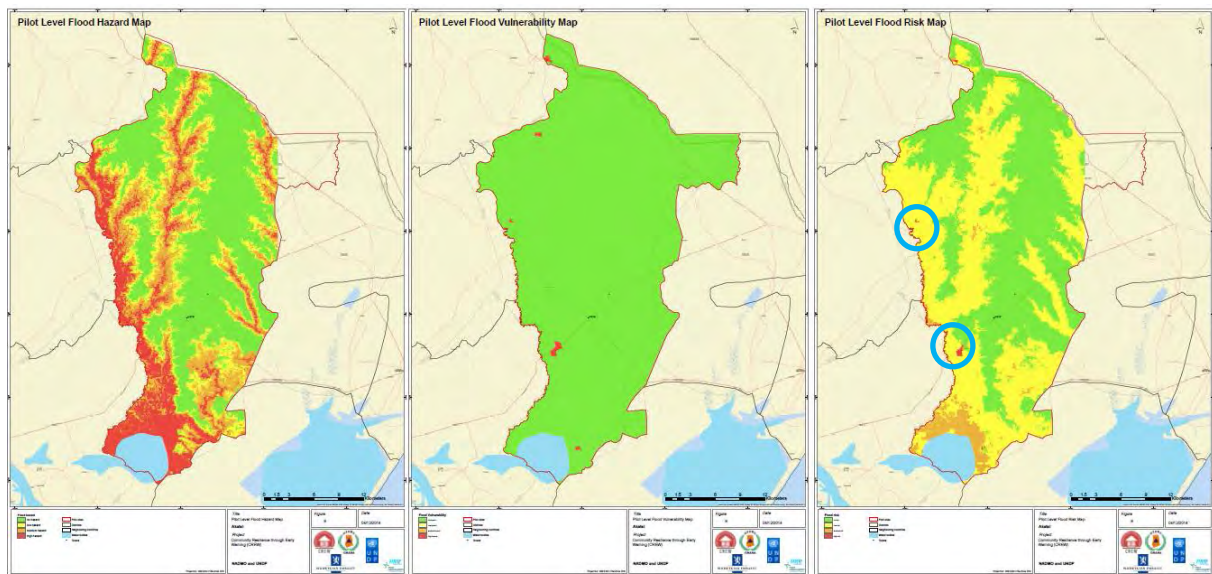
**Figure 59: Flood hazard (left), flood vulnerability (middle) and flood risk (right) in the Akatsi district**

Figure 59 presents the flood hazard, vulnerability and risk for the district. Especially the town of Torve is indicated as having a high flood risk. This was confirmed by the field visit.

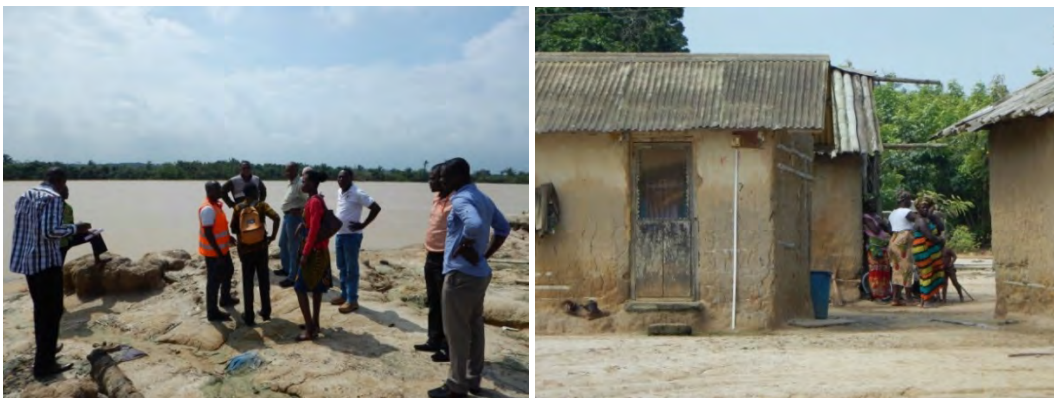
Figure 62. Interview at Krobo besides the Pra river (left), households within Krobo (right).

Krobo is a small village (~70 people) on the banks of the Pra River that suffers from flooding. Figure 61 shows 2 pictures taken during the field visit. Two community members were available to provide information. One was a member of the village elders and the second was a resident. According to these sources, the flooding occurs on average once every 5 years and it occurs when the river discharge is very high due to heavy rainfall upstream. Figure 62 shows the height of the water level during the most recent flooding.

Maximum flood levels in the village were quite substantial, at around 1 meter above the floor level of the houses. The community is located between the river and a wetland that is connected to the river by means of a culvert. Therefore the flood waters come from both sides. In response to the flood, the families move in with relatives living in the area on higher ground. The community sees resettlement as the only viable solution to their problem.
