**STRUCTURAL SYSTEMS  
RESEARCH PROJECT**

Report No.  
SSRP-2001/02

**RECONNAISSANCE REPORT OF THE  
FEBRUARY 28, 2001 NISQUALLY  
(SEATTLE-OLYMPIA) EARTHQUAKE**

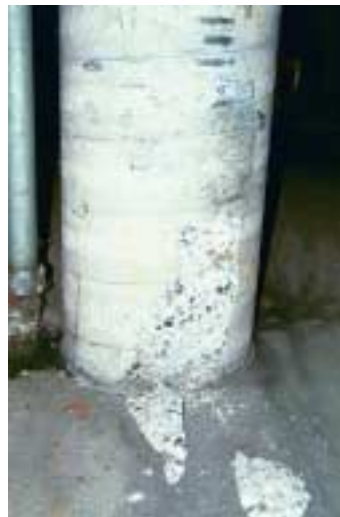
Minor spalling and cracking was also observed in the reinforced concrete columns in the parking structure under the Ramada Inn, as shown in Fig. 3.1.8.

**Figure 3.1.8** Spalling of a Reinforced Concrete Column in the Parking Structure Under the Ramada Inn.

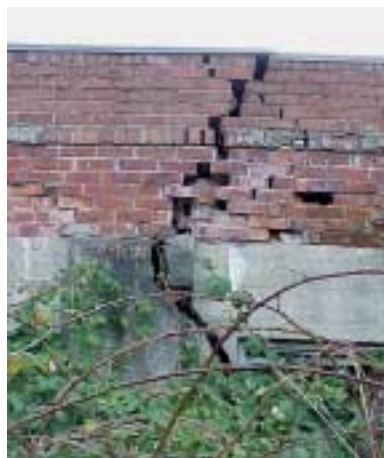
Figure 3.1.9 shows the out-of-plane failure of an old single-story masonry warehouse incorporating timber roof trusses on Second Avenue near Harrison Street in the city of Kent. The timber roof trusses were also damaged but did not collapse. A shear failure in one of the perimeter lintels was also observed, as shown in Fig. 3.1.10.

**Figure 3.1.10** Shear Failure of a Perimeter Lintel of an Old Single-Story Masonry Warehouse in Kent.

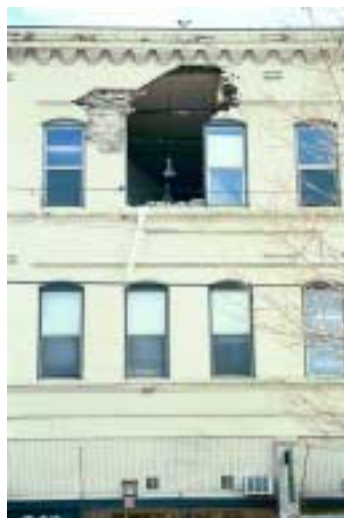
Figure 3.1.15 shows an out-of-plane failure of a large section of an unreinforced brick wall in a red-tagged three-story masonry building in the 500 block of First Avenue South in Seattle.

**Figure 3.1.15** Out-of-Plane Failure of a Section of a Masonry Wall in a Three-Story Building in the 500 Block of First Avenue South in Seattle.

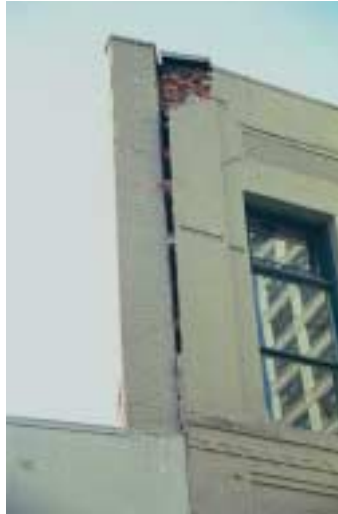
Figure 3.1.17 shows the separation of perpendicular unreinforced masonry walls in a building in the 400 block of Second Avenue in Seattle. The permanent gap that opened between the walls resulted from falling bricks lodging in the crack during the earthquake.

**Figure 3.1.17** Permanent Gap between Perpendicular Walls in a Masonry Building along the 400 Block of Second Avenue of Seattle.

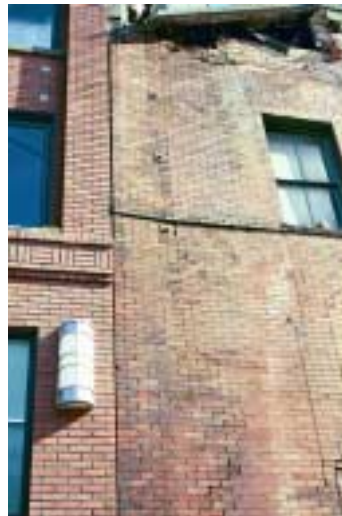
**Figure 3.1.19** Brick Facade Forced Out-of-Plane by Pounding against an Adjacent Building in the 500 Block of First Avenue South in Seattle.

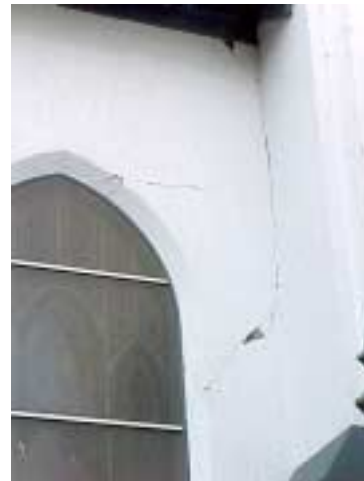
Significant in-plane cracking of masonry walls was also observed in several structures. One example of this occurred at the First Christian Church located on the corner of Seventh Avenue and Franklin Street in Olympia, as shown in Fig. 3.1.21. Diagonal cracking occurred between the large window openings and the re-entrant corners of the structure.

**Figure 3.1.21** In-plane Cracking of Masonry Walls of the First Christian Church in Olympia.

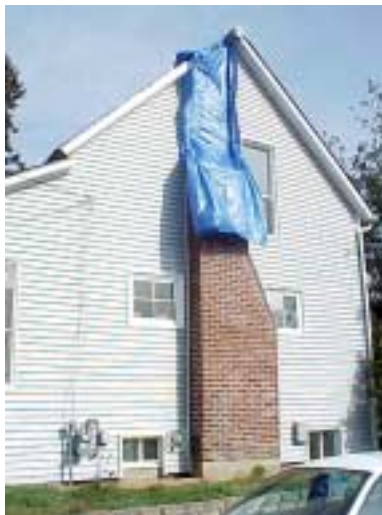
Figure 3.1.27 shows a similar chimney failure that was also observed in a two-story wood frame house located at the corner of Capital Way and Twenty-Fourth Avenue in Olympia.

**Figure 3.1.27** Chimney Failure in a Two-Story Wood Frame House in Olympia.

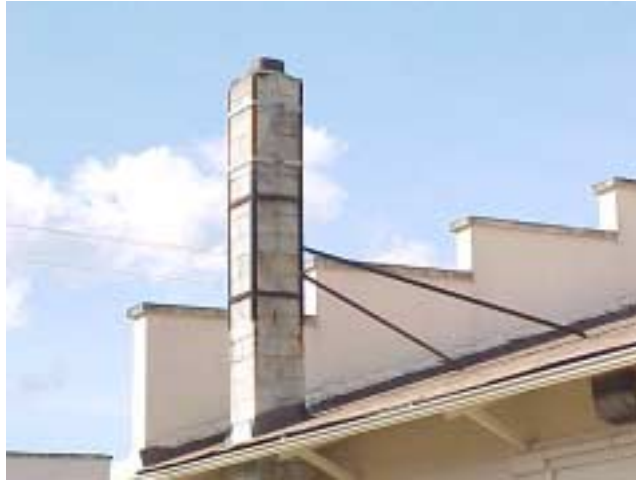
Braced chimneys, on the other hand, performed very well as shown in Fig. 3.1.28 for one of the chimneys of a wood frame army barrack in Fort Lewis.

**Figure 3.1.28** Undamaged Braced Chimney of a Wood Frame Army Barrack in Fort Lewis.

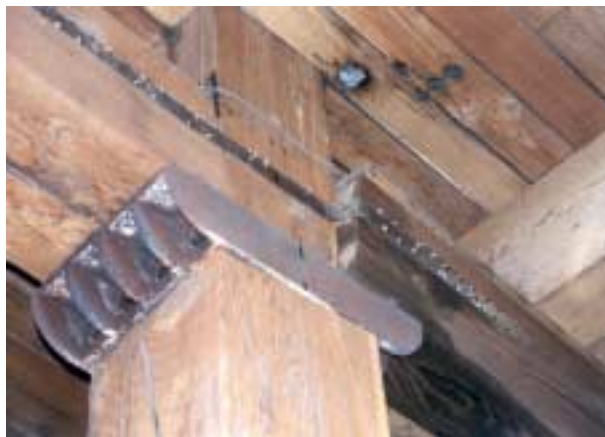
The original structural system of this building consisted of wood post-and-beam framing along with perimeter masonry walls. As shown in Fig. 3.1.31, the post-and beam connections have been upgraded with steel column caps and restraining straps.

**Figure 3.1.31** Original Wood Post-and-Beam Framing System of the Cobalt Group Building in Downtown Seattle.

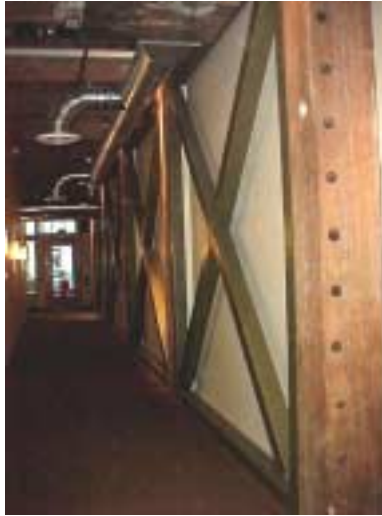
The seismic upgrade of the building also incorporated diagonal tubular steel cross-bracing systems, as shown in Fig. 3.1.32.

**Figure 3.1.32** Diagonal Tubular Cross-Braces to Seismically Upgrade the Cobalt Group Building in Downtown Seattle.

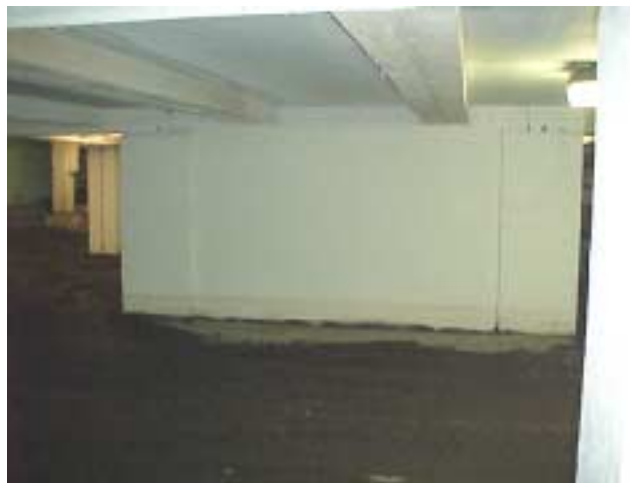
Also in the basement of the building, reinforced concrete shear walls were incorporated as in-fill to the existing reinforced concrete vertical load bearing frames, as shown in Fig. 3.1.33.

**Figure 3.1.33** Added Reinforced Concrete Shear Walls in the Basement of the Cobalt Group Building in Downtown Seattle.

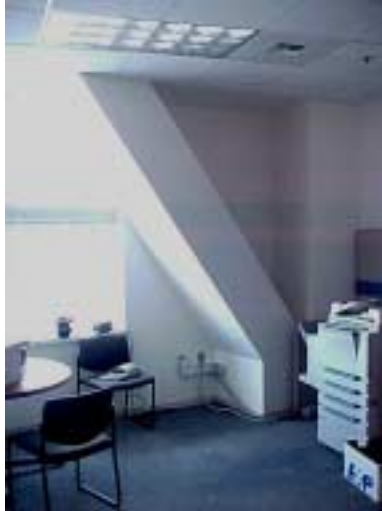
As shown in Fig 3.2.2, the lateral load resisting system of the structure consists of perimeter chevron eccentrically braced steel frames bearing on a reinforced concrete column system at the basement level. The bracing system behaved well with no sign of distress. Cracking of one of the reinforced concrete column in the basement was reported but was not considered detrimental to the normal operation of the building. The bracing system fully protected the large glass areas of the rotunda and all windows of the building.

**Figure 3.2.2** Chevron Eccentric Bracing System at Kent Regional District Center.

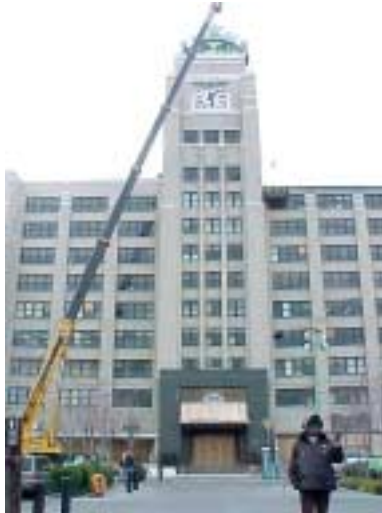
**Figure 3.2.4** East Facade of the Starbucks Headquarter in Downtown Seattle.

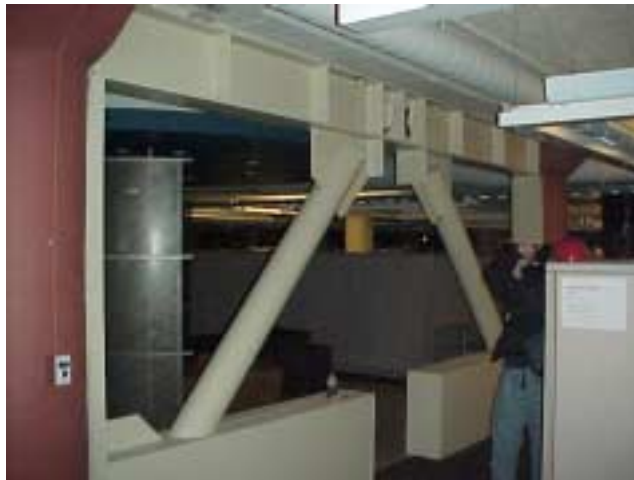
**Figure 3.2.5** Chevron Eccentrically Braced Steel Frame Used to Seismically Upgrade the Starbucks Headquarter Building in Downtown Seattle.

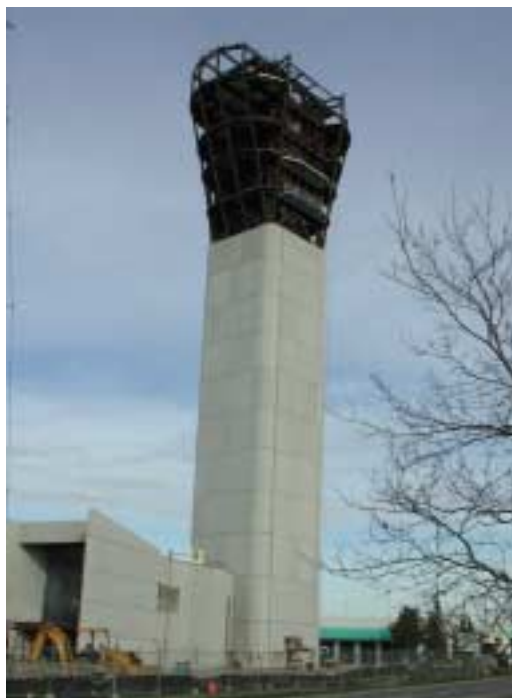
**Figure 3.2.8** Global View of New Sea-Tac Air Traffic Control Tower.

The new tower's base structure is transitioned into a 5-story steel frame structure at level 12 (47 m above the ground). The proprietary biaxial SidePlate dual system consisting of a Special Concentrically Braced Frame and a Special Moment Resisting Frame was adopted as the lateral load-resisting system. Each column is a built-up cruciform. A super X-braced configuration is used in the lower four stories, as shown in Fig. 3.2.9, while a Chevron-braced configuration is used in the top story.

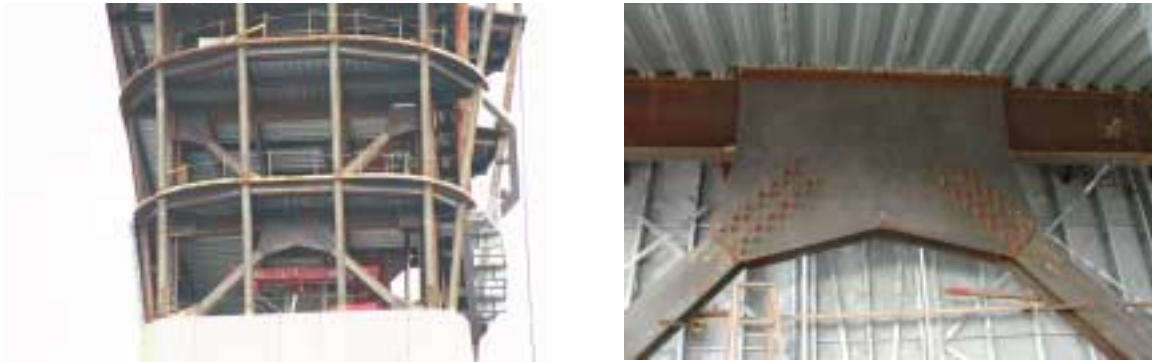
**Figure 3.2.9** Super X-Braces for Special Concentrically Braced Frame.

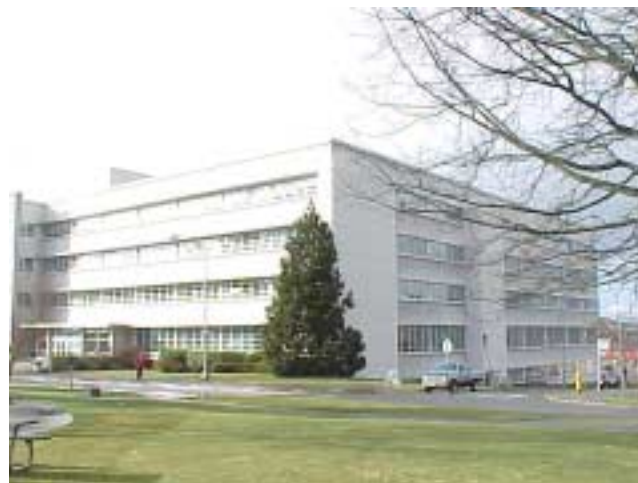
Structural damage observed in reinforced concrete buildings consisted mostly of diagonal shear cracking of lateral load-resisting shear walls. An example of this type of damage was observed in the five-story General Administration Building in Olympia, as shown in Fig. 3.3.1.

**Figure 3.3.1** General Administration Building in Olympia.

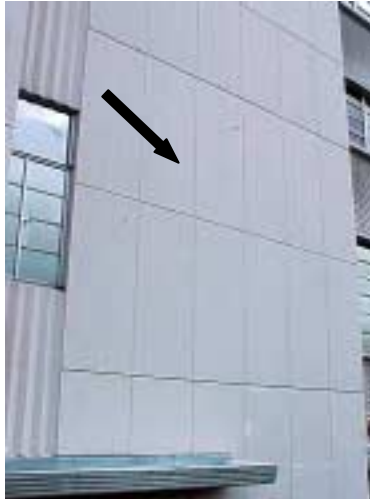
The lateral load resisting system in the north-south direction consists of pairs of shear walls along the east and west faces of the building. On each face, one wall is located at mid-length of the building, while the second wall is located at the corner near the south face of the building. As shown in Fig. 3.3.2, diagonal shear cracking occurred in the central walls between the first and second floor. This cracking could also be observed on the inside faces of these walls.

**Figure 3.3.2** Diagonal Cracking in Central Shear Walls of General Administration Building in Olympia.

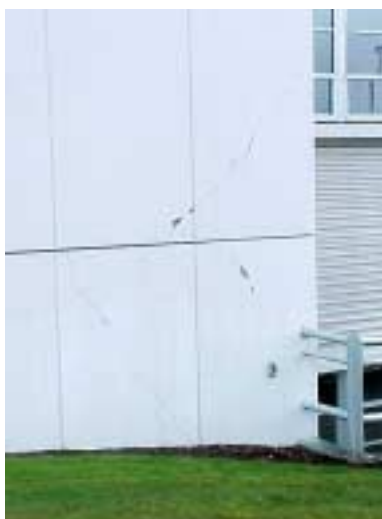
Similar diagonal cracking was also observed in the corner walls of the building, as shown in Fig. 3.3.3. Furthermore, the damage observed in the south bottom corners of these walls, as shown in Fig. 3.3.4, suggested also that significant rocking had occurred.

**Figure 3.3.3** Diagonal Cracking in Corner Shear Walls of General Administration Building in Olympia.

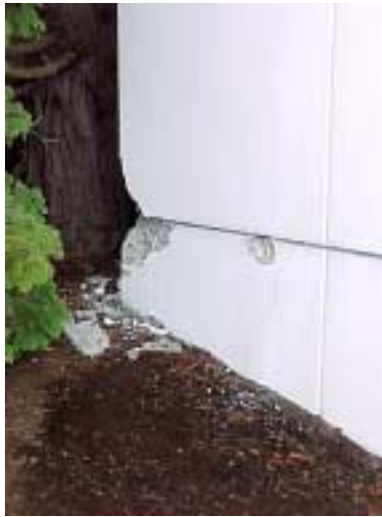
**Figure 3.3.4** Damage in North Bottom Corners of Shear Walls of General Administration Building in Olympia.

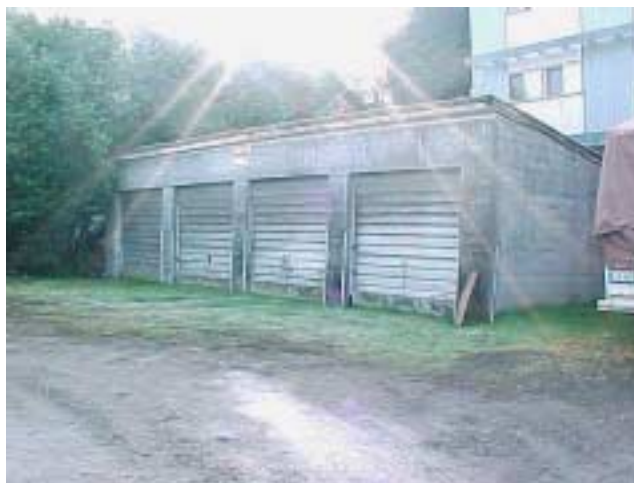
Figures 3.3.5 and 3.3.6 show the damage suffered by a concrete detached garage unit located on Franklin Street in Olympia. The concrete frame in the open front suffered cracking in the beam-to-column connections. One existing horizontal crack expanded during the earthquake, causing the column to lean sideways, thereby jamming the garage door.

**Figure 3.3.5** Concrete Garage Unit on Franklin Street in Olympia.

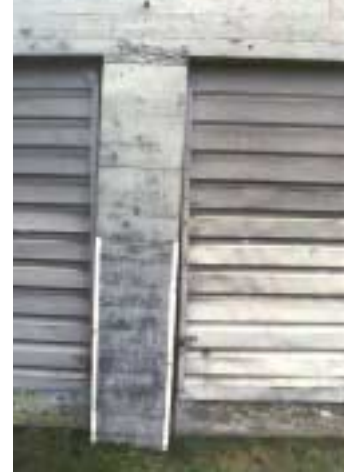
**Figure 3.3.6** Cracking in Beam-to-Column Joints of a Concrete Garage Unit on Franklin Street in Olympia.

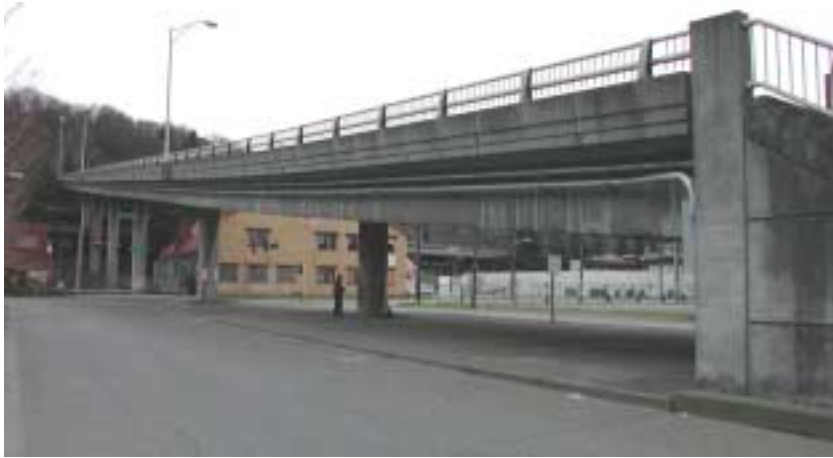
**Figure 4.1.1** General View of Holgate Bridge.

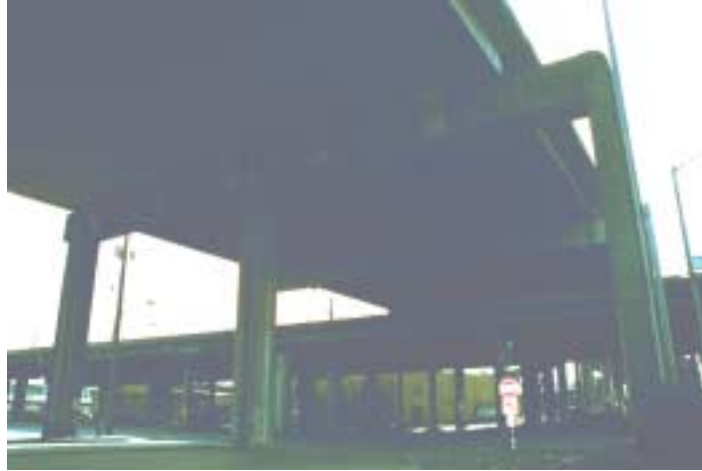
The Overcross from Bent 25 to Bent 28 sustained damage to the superstructure. Figure 4.2.1 shows the Overcross observed from Bent 25. Both Bent 25 and Bent 28 are constructed of reinforced concrete, with a column height of 14.6 m. The reinforced concrete box girder superstructure transitions to the steel girder superstructure between Bent 25 and Bent 28. Figure 4.2.2 shows the transition at Bent 25. Note the split column with a 50 mm expansion gap that starts at a 9.75 m column height. The gap was introduced to allow for thermal movement of the superstructure.

**Figure 4.2.1** Spokane Bridge Overcross.

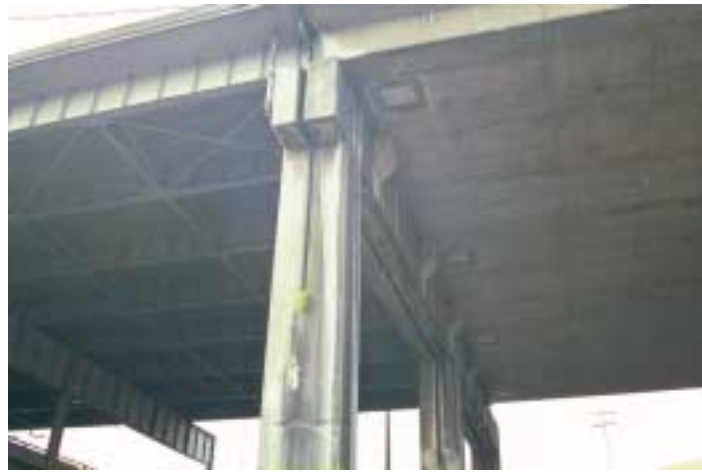
**Figure 4.2.2** Bent 25 with Split Reinforced Concrete Columns.

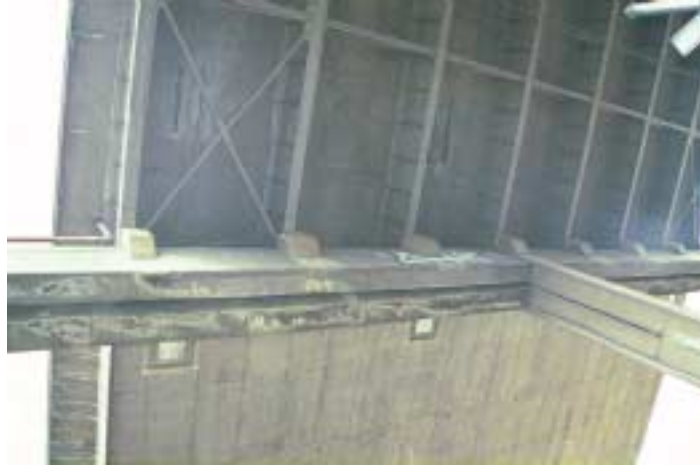
Figure 4.2.3 shows catchers that were installed underneath each steel girder. Lateral movement of the steel superstructure resulted in the steel brackets bolted to the catcher on each side of the steel girder to shear off, as shown in Fig. 4.2.4. The cross-braced diaphragm at the end of steel superstructure provided the load path to transmit the inertia force at the deck level to the support at the bottom flange level. Figure 4.2.5 shows a buckled brace in the end diaphragm, implying a larger seismic response toward the east direction.

**Figure 4.2.3** Stage 1 Seismic Retrofit with Catchers and Restrainers in Bent 25.

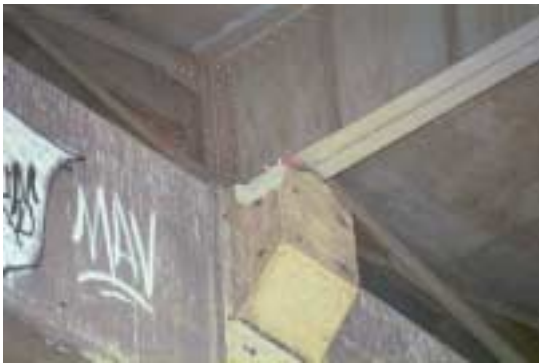
**Figure 4.2.4** Damage to Catchers.

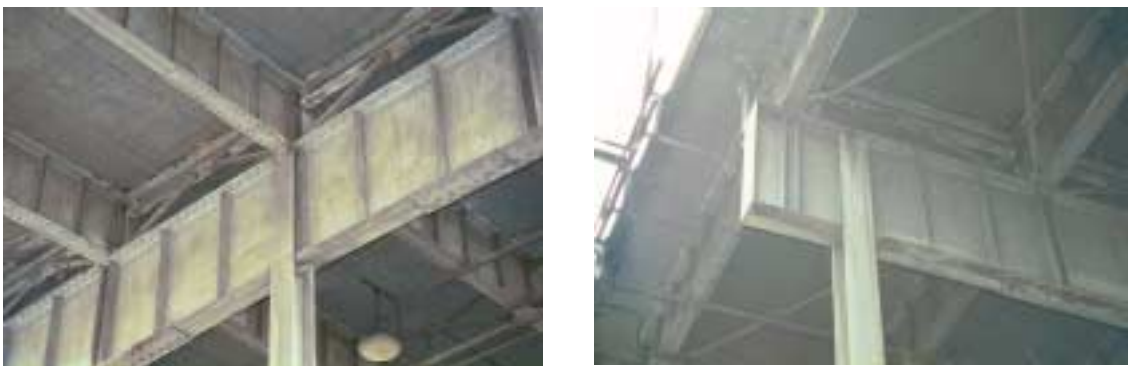
Steel Bent 26 and Bent 27, designed to support the gravity load of the superstructure, are located on both sides of Spokane St. Viaduct, which runs perpendicular to the overcross, as shown in Fig. 4.2.7. Each steel bent is composed of three wide flange columns, oriented with the weak-axis bending in the transverse direction. Figure 4.2.8 shows minor yielding (paint flaking) at the base of an exterior column. No damage was observed in these steel bents.

**Figure 4.2.7** Bent 26 with Steel Substructures.

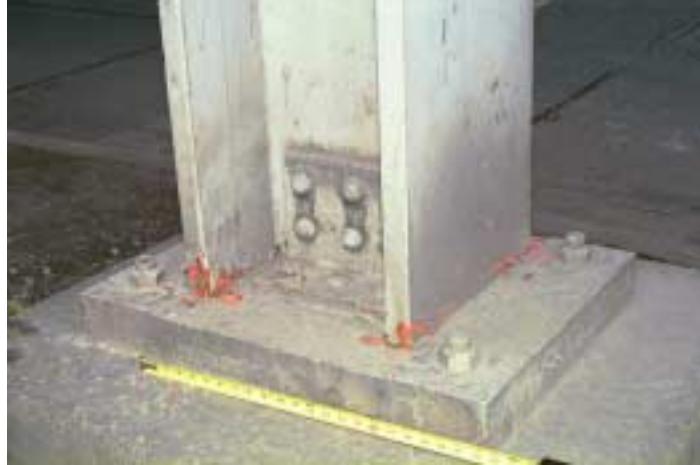
**Figure 4.2.8** Yielding at Exterior Column Base of Bent 26.

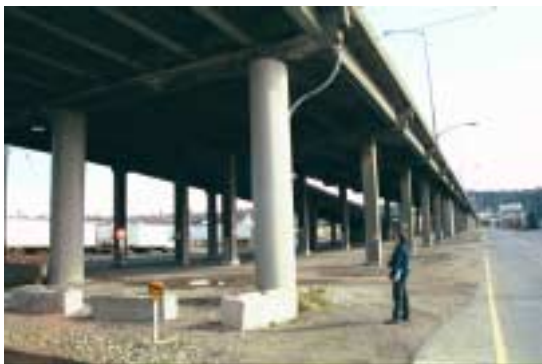
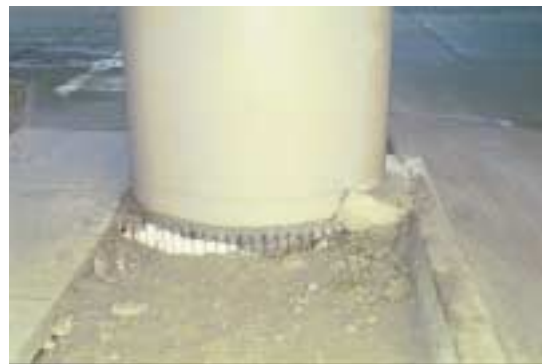
The elevated Spokane St. Viaduct between I5 and SR99 serves four lanes of traffic, two lanes in each direction. The elevated roadway is composed of repeating segments of continuous reinforced concrete girders connected by steel girders at the surface street intersection. The City of Seattle retrofitted the substructure by steel jacketing reinforced concrete columns every few bents, as shown in Fig. 4.3.1. Where the steel jacket extends below the ground to the top of foundation, PVC pipes are used to make room for the column to deflect laterally. Figure 4.3.1 shows evidence of lateral deflection of the column, yet no damage was observed. Cable restrainers used to connect superstructures also remained intact, as shown in Fig. 4.3.2.

**Figure 4.3.1** Steel Jacketed Reinforced Concrete Columns.

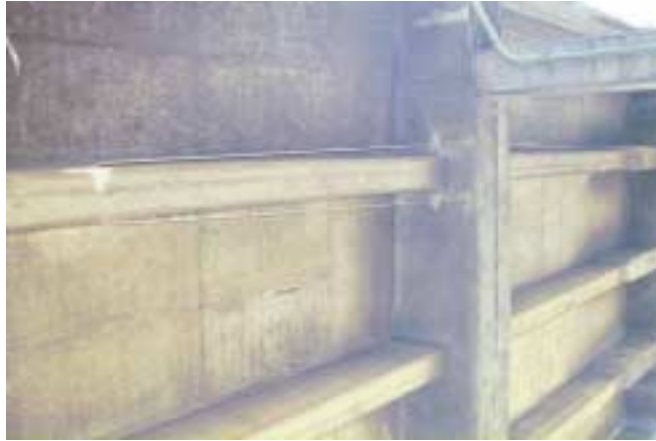
**Figure 4.3.2** Cable Restrainers in Superstructures.

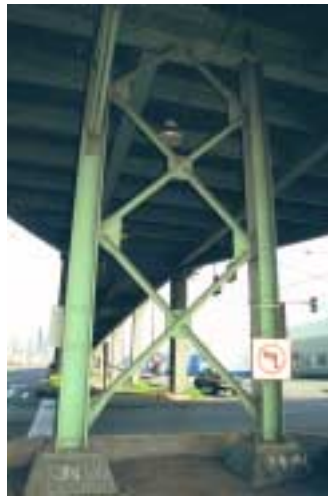
Steel superstructures and substructures were used at the intersections with surface streets. X-braced bents were used as the substructure in the longitudinal direction, as shown in Fig. 4.3.3. No damage was observed in the braced bents, but flaking of paint at gusset connections, indicative of the seismic effect, was evident as shown in Fig. 4.3.4. Flaking at the column base was also observed, as shown in Fig. 4.3.4. Knee-braced bents were used in the transverse direction, which displayed signs of yield as seen in Fig. 4.3.5. Paint flaking in the steel substructure clearly showed that the bridge was shaken in both directions.

**Figure 4.3.3** X-braced Steel Substructure.

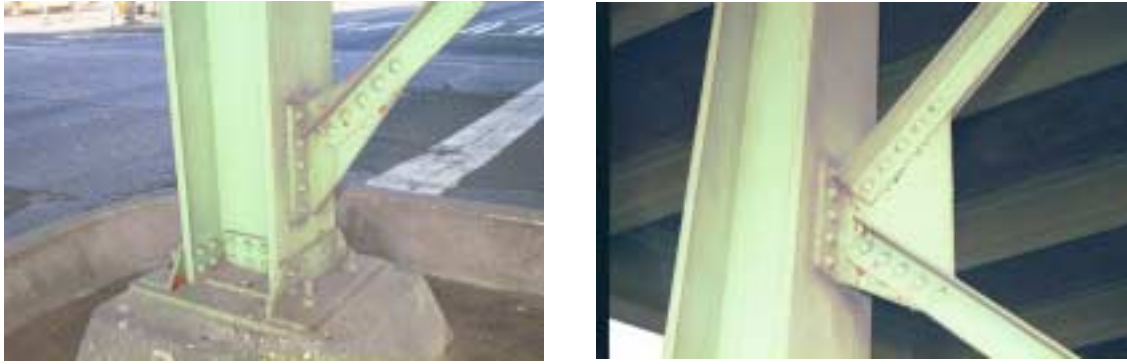
**Figure 4.3.4** Paint Flaking at Column Base and Gusset Connections.

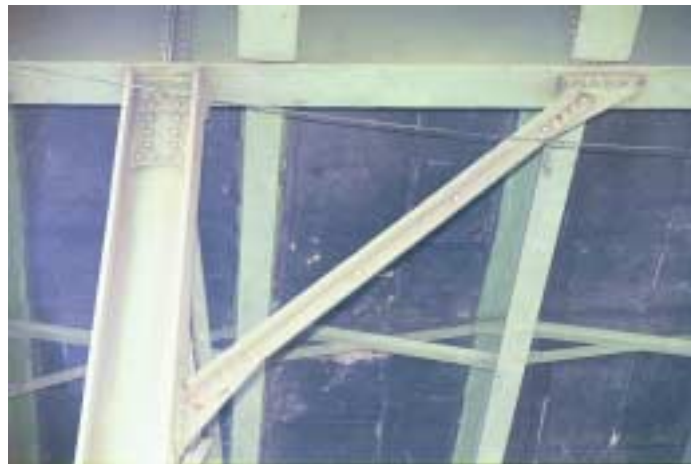
**Figure 4.3.5** Paint Flaking at Knee Brace.

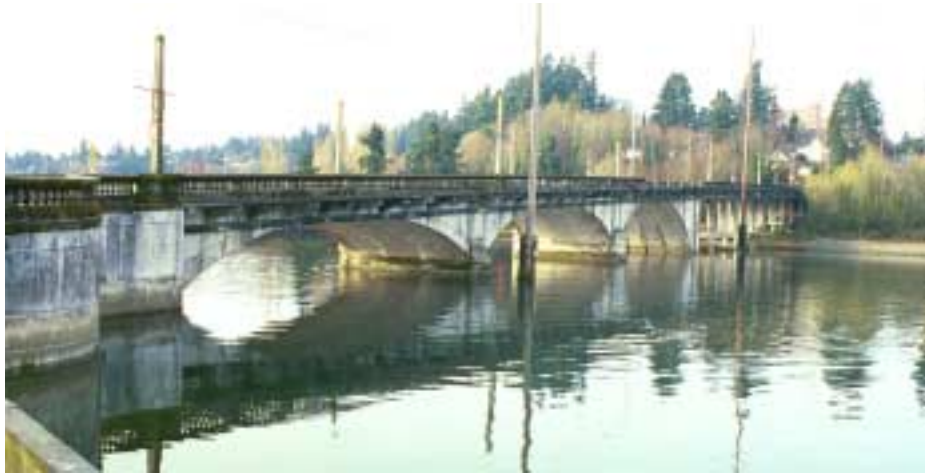
The Fourth Avenue Bridge spans the east and west ends of a small inlet in the southern tip of Puget Sound. It provides two lanes of traffic with pedestrian walkways on each side. Built in 1920, the bridge uses a Luten concrete arch for the main spans with a standard concrete column supported approach span on the west side, as shown in Fig. 4.4.1. The arch is filled with gravel so that the uniform compression desirable for arched structures can be maintained. The bridge was originally designed for trolley car loads of  $7.18 \text{ kN/m}^2$ , which resulted in ample reserve strength for vehicular traffic. However, the bridge is currently in a state of decay, which is depleting this reserve strength. Due to corrosion caused by water seeping through the expansion joints and moderate damage caused by prior earthquakes in the region in 1949 and 1965, the bridge was slated for replacement by the city of Olympia before the

Nisqually earthquake. The bridge is currently closed and traffic is being re-routed to an adjacent bridge.

**Figure 4.4.1** Global View of Fourth Avenue Bridge.

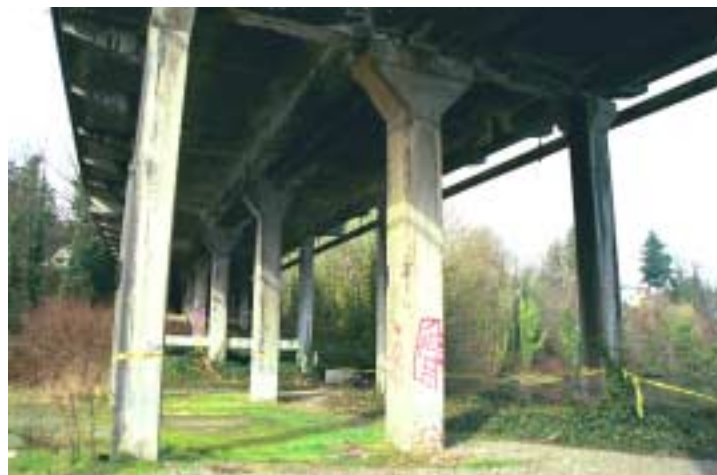
Seismic damage to the Fourth Avenue Bridge is isolated to the column supported section and the pedestrian handrails. Square reinforced concrete columns flared on top are used to support the west approach span. Each bent consists of three columns with the flare running parallel to the bridge in the outer columns and perpendicular to the bridge in the inner columns, as shown in Fig. 4.4.2. An example of typical damage that occurred at the base of the column flares is given in Fig. 4.4.3. Spalling of the concrete implies that considerable hinging took place at this location. It is important to note, however, that the bridge was in poor condition prior to the Nisqually earthquake and existing damage was further exacerbated by this recent event. An example of column cracking that existed in 1994 is shown in Fig. 4.4.4.

**Figure 4.4.2** Bridge Bent Configuration.

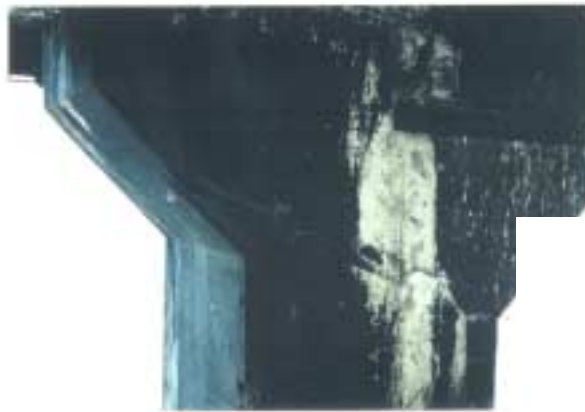
**Figure 4.4.4** Bridge Column Condition in 1994<sup>2</sup>.

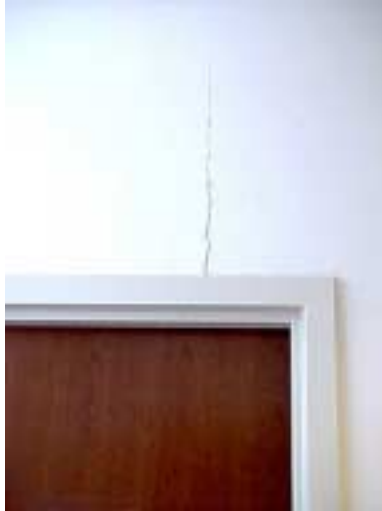
One interesting observation on the cracking of drywall finish was made at the Kent Regional District Center. Vertical cracking occurred at the upper corner of almost all interior doors of the building. As shown in Fig 5.2.2, cracks were observed on only one side of each door.

**Figure 5.2.2** Vertical Cracking of Drywall Finish Above a Door Opening at Kent Regional District Center.

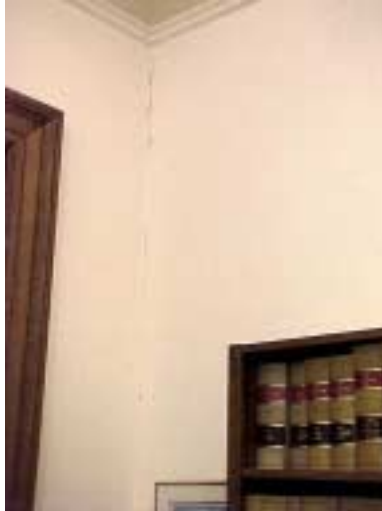
Vertical cracking of wall finishes at the corners of perpendicular walls was observed in a number of buildings. Figure 5.2.4 shows an example of this type of cracking that occurred for the plastered walls of the Supreme Court located in the Temple of Justice Building in Olympia.

**Figure 5.2.4** Vertical Cracking of Plastered Walls in the Supreme Court of the Temple of Justice in Olympia.

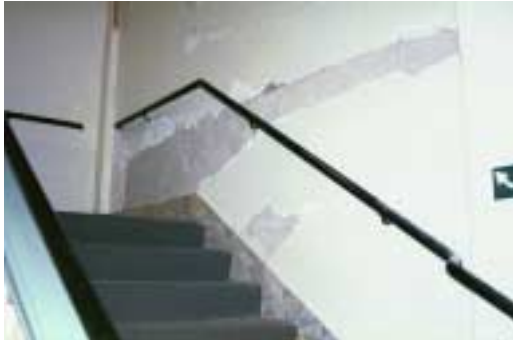
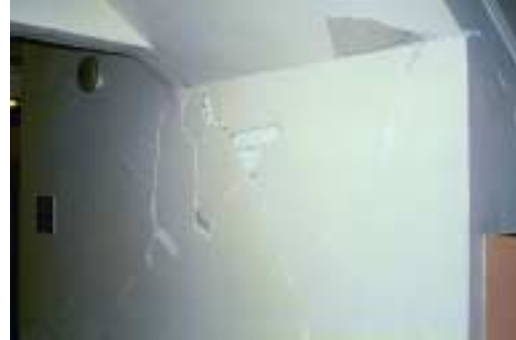
Substantial cracking of interior wall finish materials was observed in the stair well of the yellow-tagged Olympian Apartments at 519 Washington Street in Olympia.

**Figure 5.2.5** Cracking of Plastered Walls in the Stair Wells of the Olympian Apartments in Olympia.

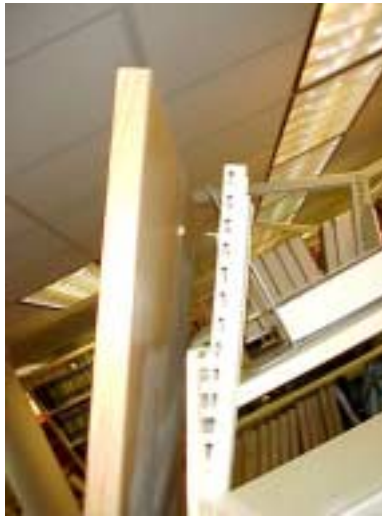
Another source of damage to non-structural components was the tumbling of building contents during the earthquake. Figure 5.5.1 shows, for example, the failure of bookshelves that caused some books to fall in the main library of the Temple of Justice Building in Olympia. Figure 5.5.2 shows a detail of the screwed wood-to-metal connection that failed at the top of one of the leaning bookshelves.

**Figure 5.5.2** Failed Screwed Wood-to-Metal Connection at Top of a Leaning Bookshelf in the Main Library of the Temple of Justice Building in Olympia.

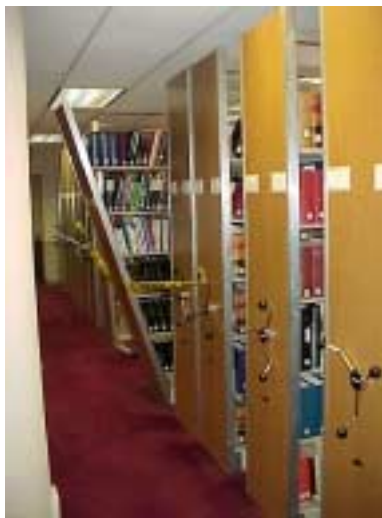
This library contained also sturdier movable compact bookshelves mounted on a floor railing. As shown in Fig. 5.5.3, these shelves did not suffer any visible damage during the earthquake and seemed to remain functional.

**Figure 5.5.3** Undamaged Movable Compact Bookshelves and Leaning Conventional Bookshelves in the Main Library of the Temple of Justice Building in Olympia.

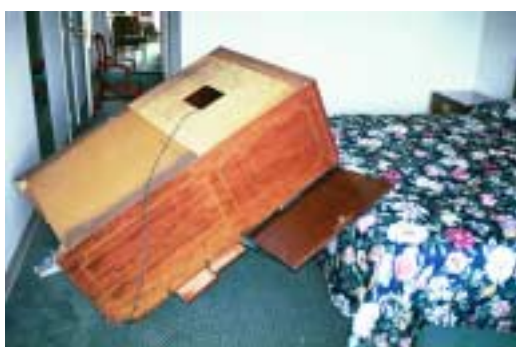
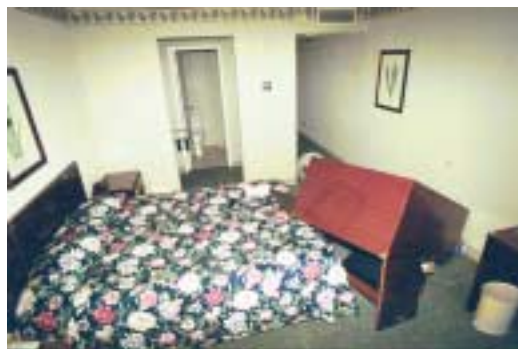
The majority of the furniture in the top three floors of the eight-story Ramada Inn at 621 Capitol Way in Olympia was overturned as a result of the building shaking. Figure 5.5.5 shows typical examples of the damage to furniture in quest rooms on the eighth floor. In the bottom five floors most of the furniture remained in the upright position. None of the room furniture in the building had been fastened to the walls to prevent overturning.

**Figure 5.5.5** Overturned Furniture in the Guest Rooms on the Eighth Floor of the Ramada Inn in Olympia.

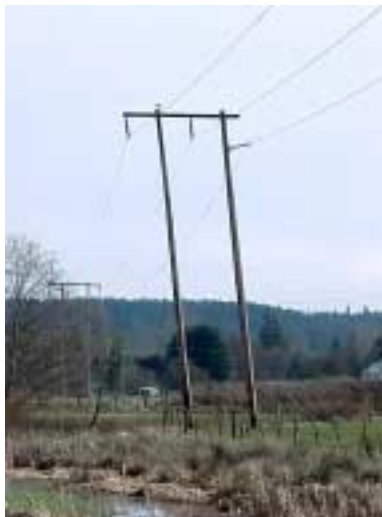
No damage to electrical power generation and distribution systems was reported during the period of the field reconnaissance. The only observed effect of the earthquake on electrical equipment was the permanent lateral deformation of a wood pylon in the epicentral region of Nisqually Valley, as shown in Fig. 5.7.1.

**Figure 5.7.1** Permanent Lateral Drift of a Wood Electrical Pylon in the Epicentral Region of Nisqually Valley.
