**A report of the collision  
that occurred on 8 January 1991  
at Cannon Street Station**

London: HMSO

I report for the information of the Secretary of State for Transport in accordance with the direction dated 14 January, 1991 the result of my Inquiry into the collision of a passenger train with the buffer stops at the end of one of the platforms at Cannon Street Station, London, on Tuesday 8 January, 1991.

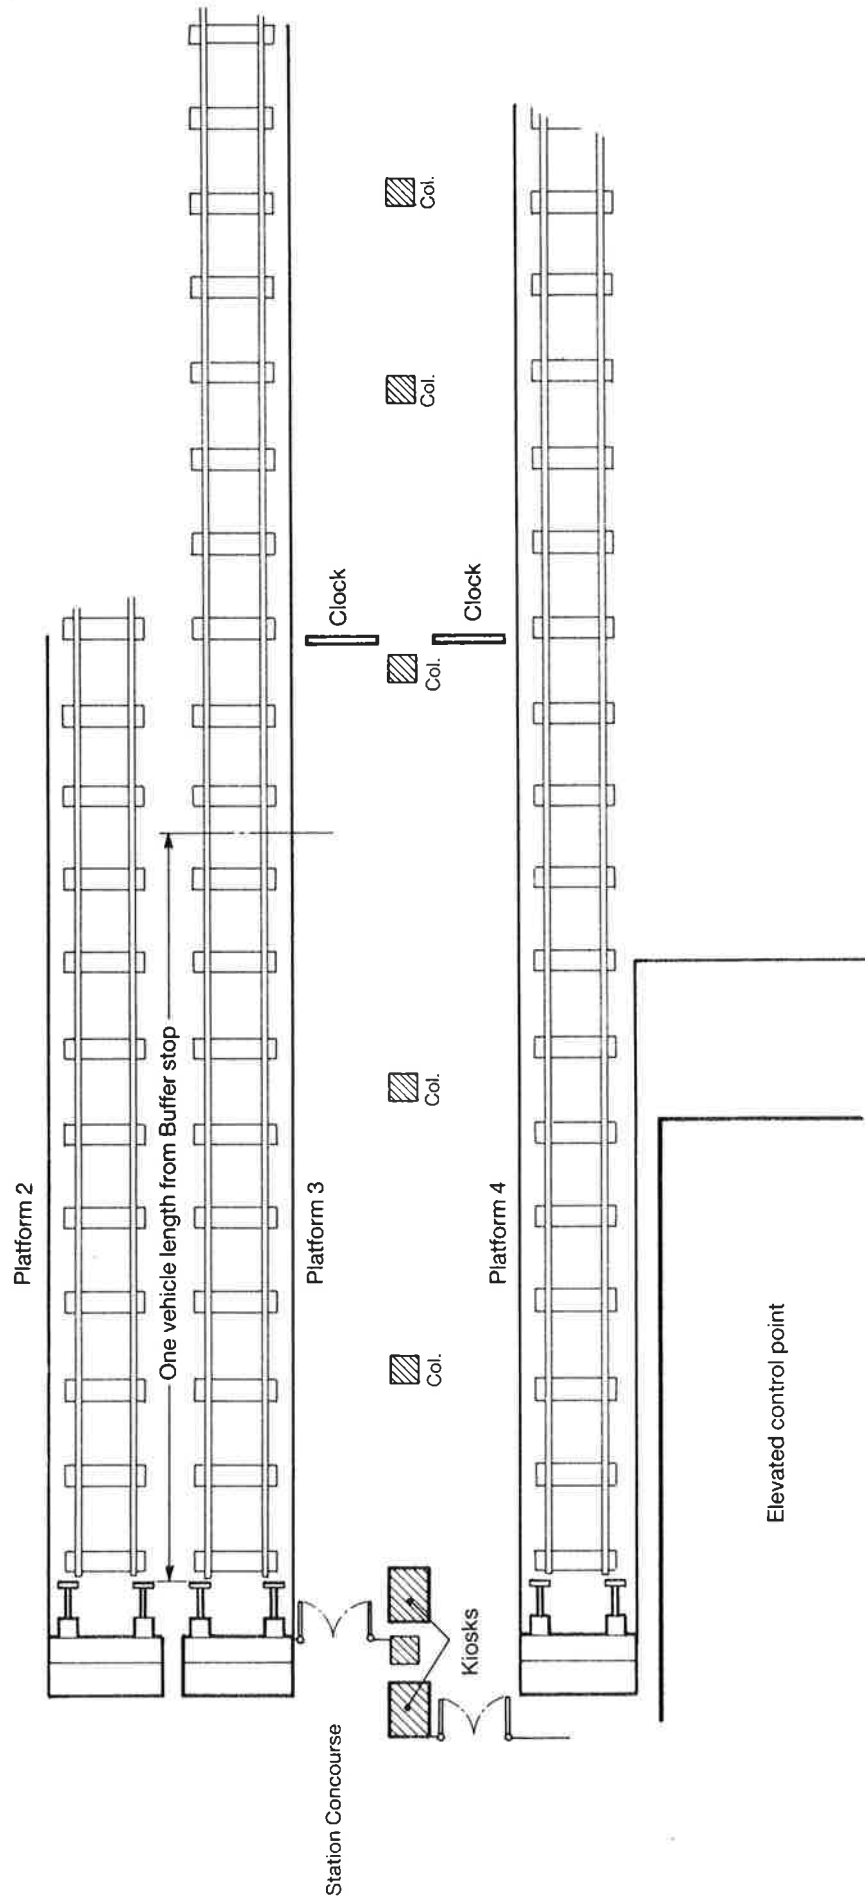
**Figure 1** Cannon Street Station plan of buffer stop area.

3 The station comprised eight platforms with platforms 1 to 4 capable of taking trains of up to ten cars in length and platforms 5 to 8, trains of up to 12 cars in length. Each platform was provided with hydraulic buffer stops of considerable age. The layout of the station is shown in Figure 1.

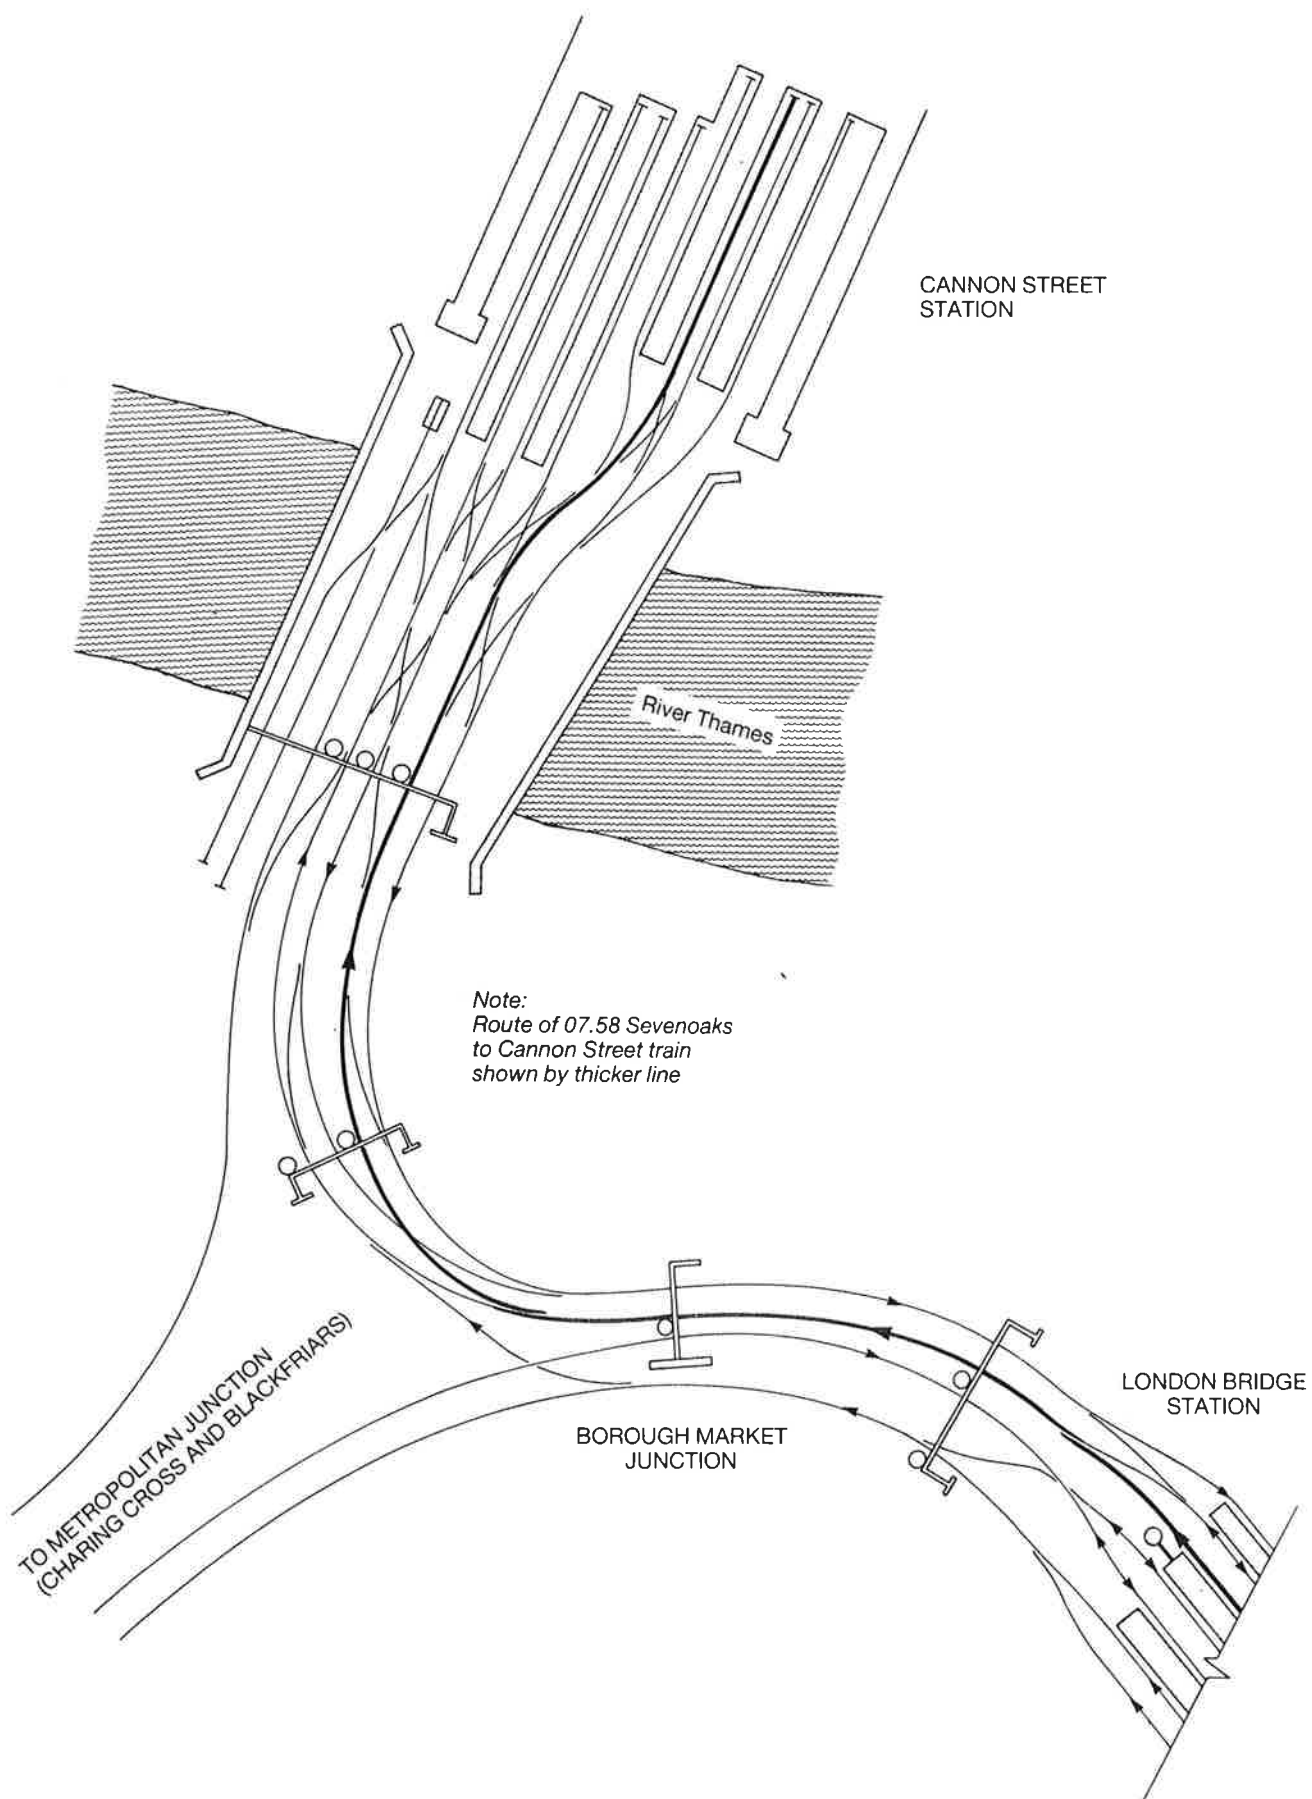
**Figure 2** Track layout on approaches to Cannon Street Station

5 The track layout at the time of the accident on the approaches to Cannon Street Station is shown in Figure 2. From Borough Market Junction to Cannon Street Station there are four running lines: up fast; down fast; up slow; and down slow; from left to right in the direction of approach to Cannon Street. A permanent speed restriction of 20 mile/h applies on all lines between Borough Market Junction and the platform approaches at Cannon Street with a 15 mile/h permanent speed restriction applying thereafter.

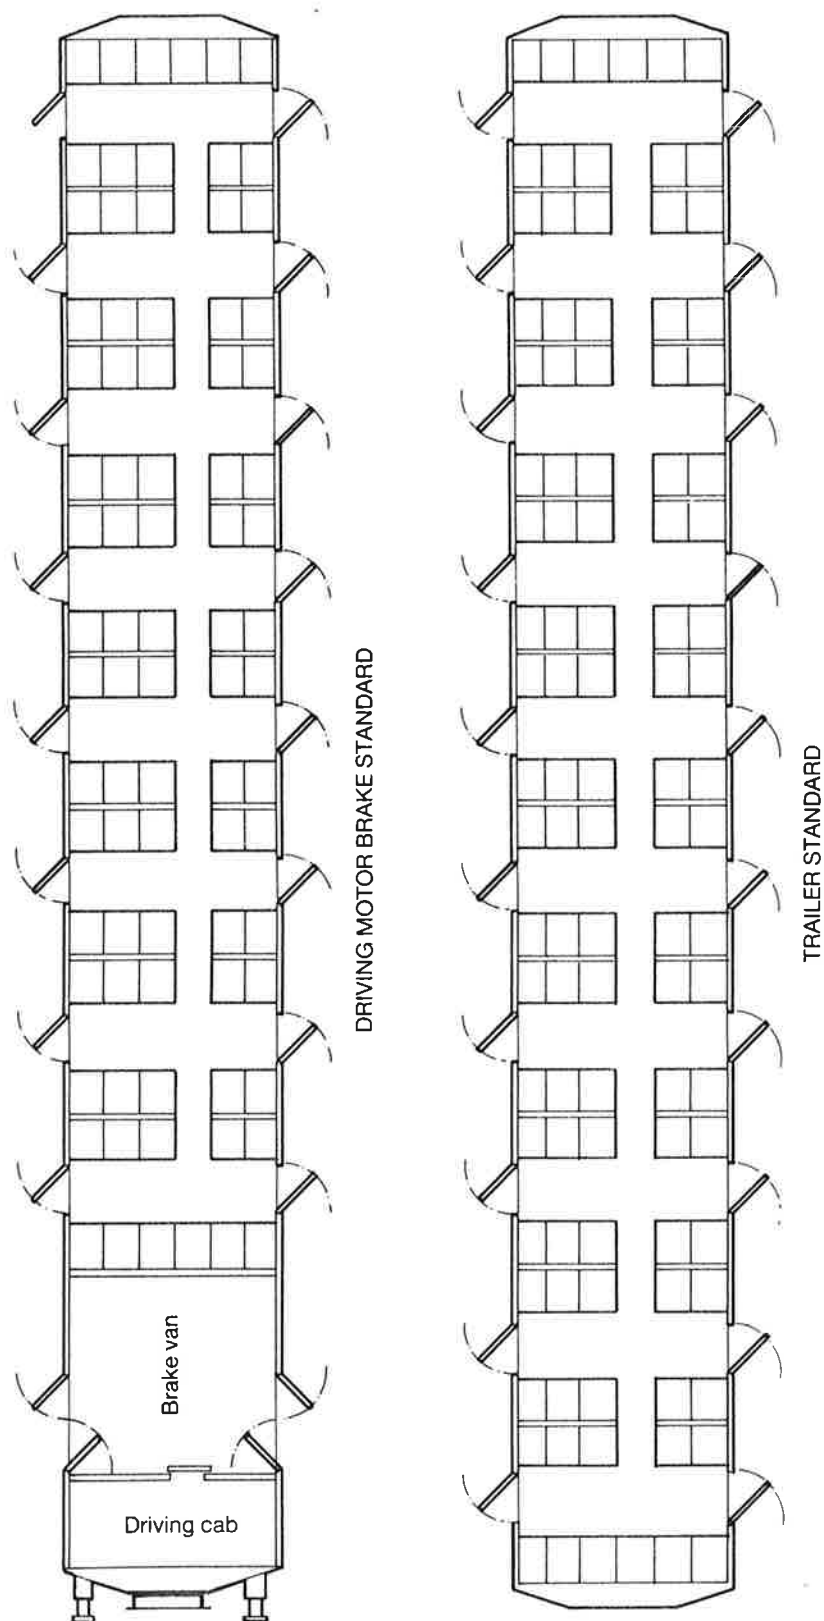
**Figure 3** Seating arrangement of electrical multiple unit

12 The intermediate trailer coaches of unit Nos 5618 and 5484, that is, vehicle Nos 70444, 70443, 15308 and 15031, each had 102 standard class seats in an open saloon. The driving trailer coach No 77526 of unit No 6227 had a driving cab with an access vestibule at the end and 102 standard class seats in a mixture of open saloon and individual compartments. The typical seating arrangement is shown in Figure 3.

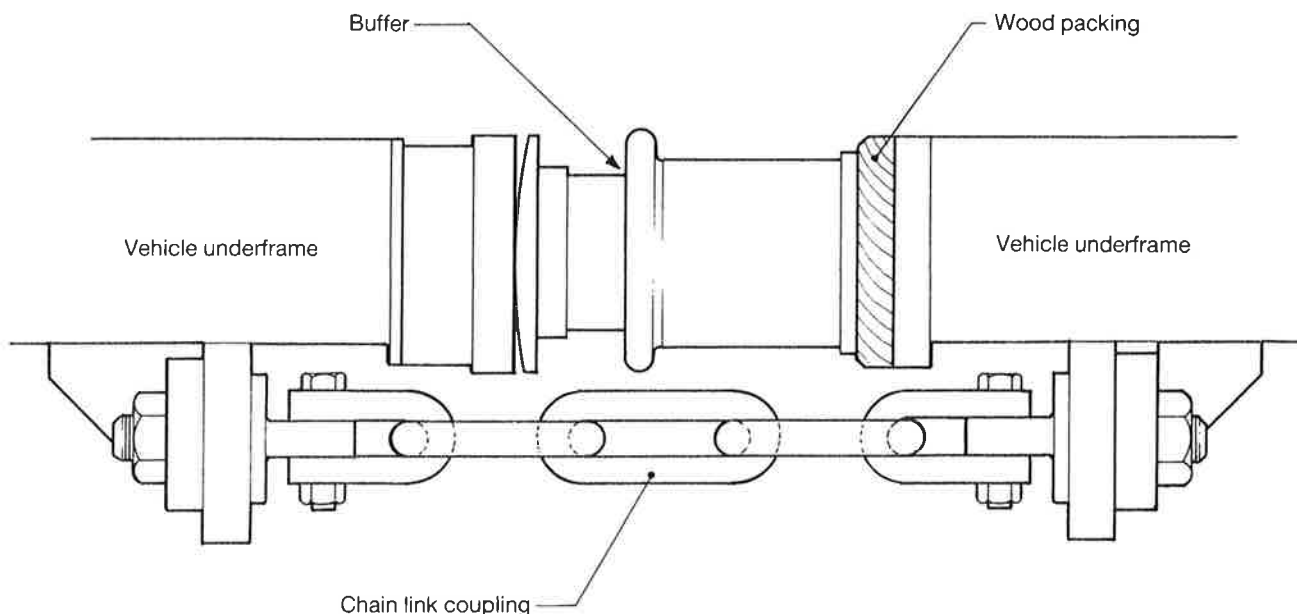
**Figure 4** Centre buffer and coupling

13 There were no gangway connections between the units or individual vehicles in the units. Each compartment or seating bay had individual hinged, passenger-operated (slam) doors. The outer ends of the units were equipped with side buffers and an automatic coupler. The internal couplings within the unit were provided by a centre buffer and chains. This arrangement is shown in Figure 4.

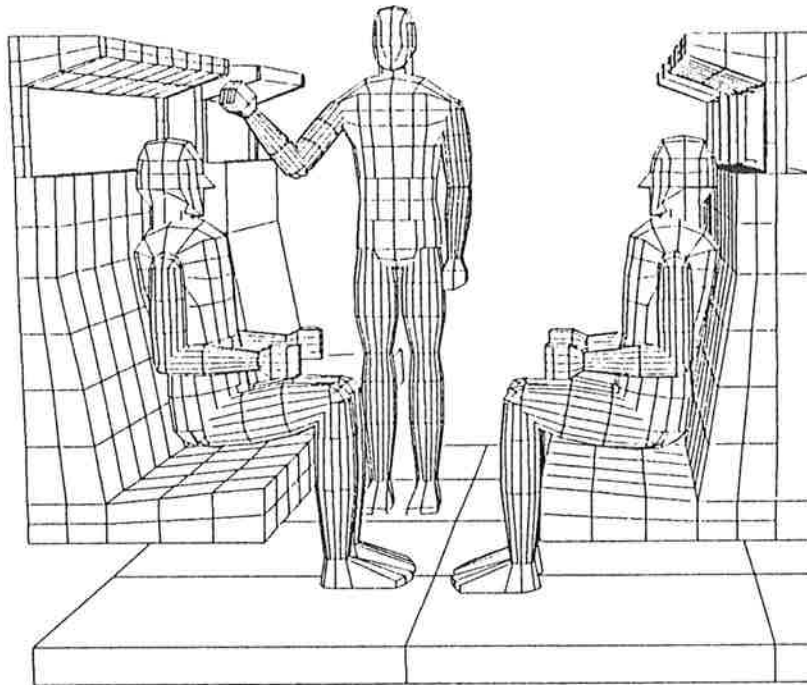
**Figure 6** Five mile/h impact

191 In the 15 mile/h the passenger seated facing the direction of travel initially slid forward in his seat with his feet sliding across the floor until his feet and knees came into contact with the passenger opposite. The force generated by this contact was enough to pitch him head first into the chest of the other passenger. The passenger seated with his back to travel was pressed into his seat with his head and elbows hitting the seat back. His feet also slid along the floor until his legs came into contact with the front of the seat. He was then struck violently by the other passenger (see Figure 6).
